**CALIFORNIA UNDERGROUND FACILITIES SAFE EXCAVATION BOARD
INVESTIGATION DIVISION
INVESTIGATION REPORT**

DATE: January 3, 2022

CASE No.: 20SA01279

Excavator struck natural gas distribution branch connection in downtown San Francisco, causing a release of gas, which subsequently ignited.

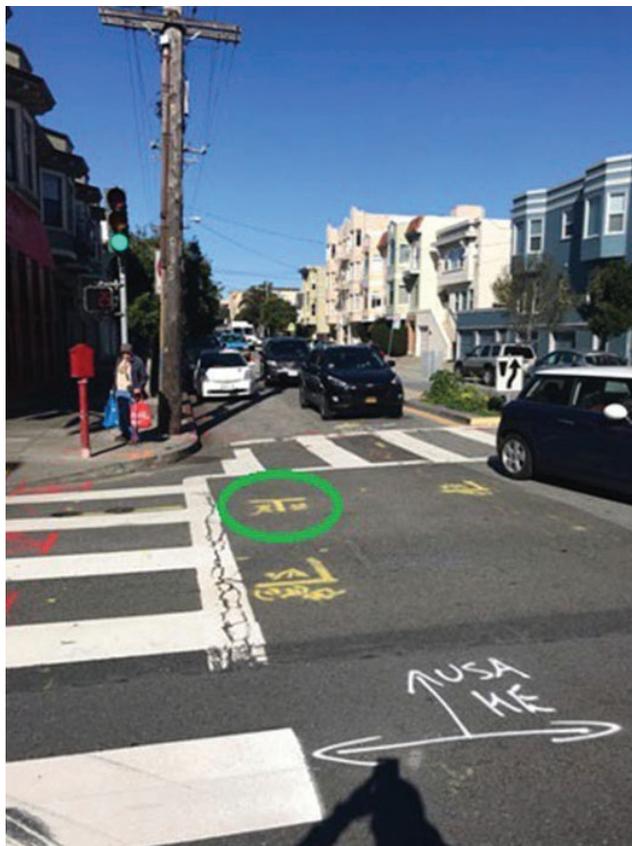
Figure 2: PG&E Locate & Mark Photo, pointing north along Parker Ave. The connection that was struck on February 6 is circled in green. Courtesy NTSB.

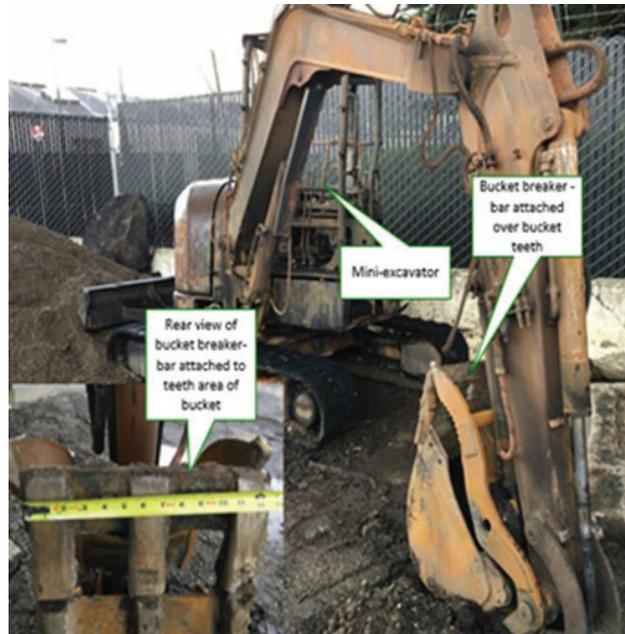
Figure 4: Post accident photo of mini excavator with enlarged view of bucket breaker. Courtesy NTSB.

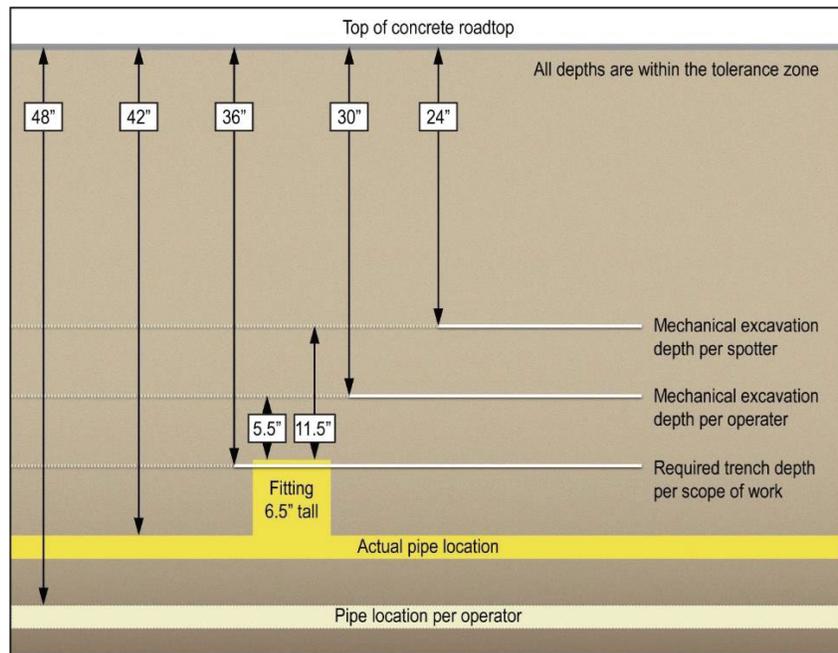
Figure 5: Comparisons of actual trench and pipe depths with the beliefs expressed by the operator of the excavator and the spotter, Courtesy NTSB.

Martin the spotter thought the trench depth was 24 inches at the time of the accident, and Codd the driver of the mini excavator thought he was digging at 30 inches. Although the Codd believed they had exposed the pipelines at a depth of 48 inches, post-accident evidence revealed that the pipelines were at a depth

of 42 inches. Based on an exemplar branch connection, the branch connection was about 6.5 inches above the 4-inch pipeline. Therefore, the depth of cover at the branch connection location was about 35.5 inches, about the same depth that was to be excavated by Kilford's crew. Although the crew thought they were digging above where they believed the pipelines were located, the evidence indicates that the pipelines and branch connection were higher than where they estimated, and Codd was likely using the excavator to dig deeper than they estimated.

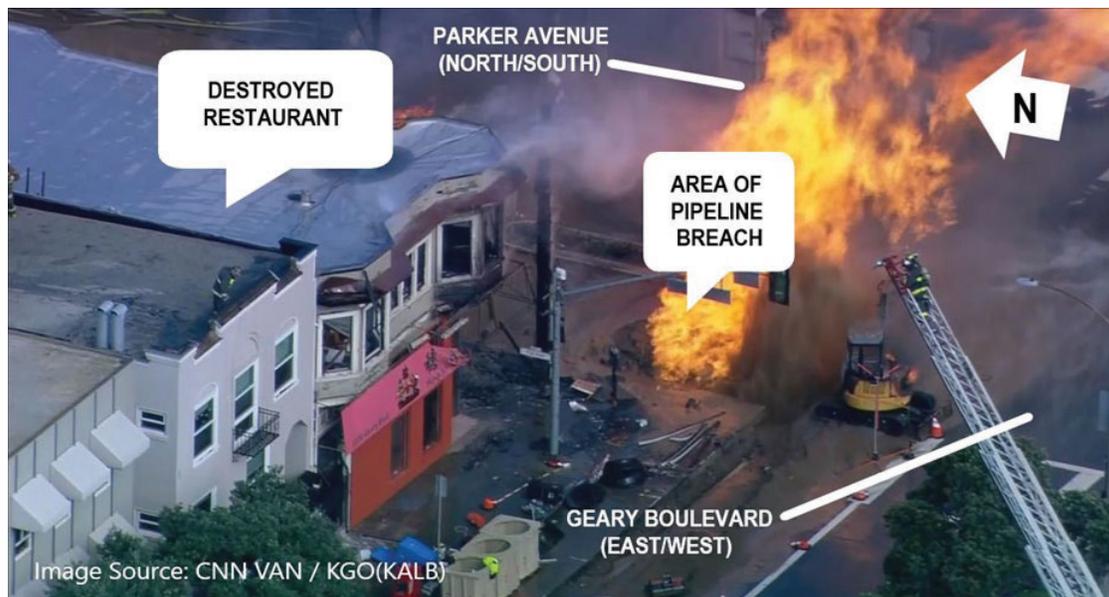
Once the gas ignited, the flames, which extended above the height of a 2-story building, impinged on a nearby, fully occupied restaurant at 3300 Geary Boulevard. This caused a structure fire at the restaurant. Employees and customers self-evacuated immediately. Later, the fire spread to neighboring buildings, causing smaller structure fires at 3308, 3310, and 3250 Geary Boulevard (**Figure 6**)

Figure 6: Aerial view of incident scene. Courtesy NTSB.

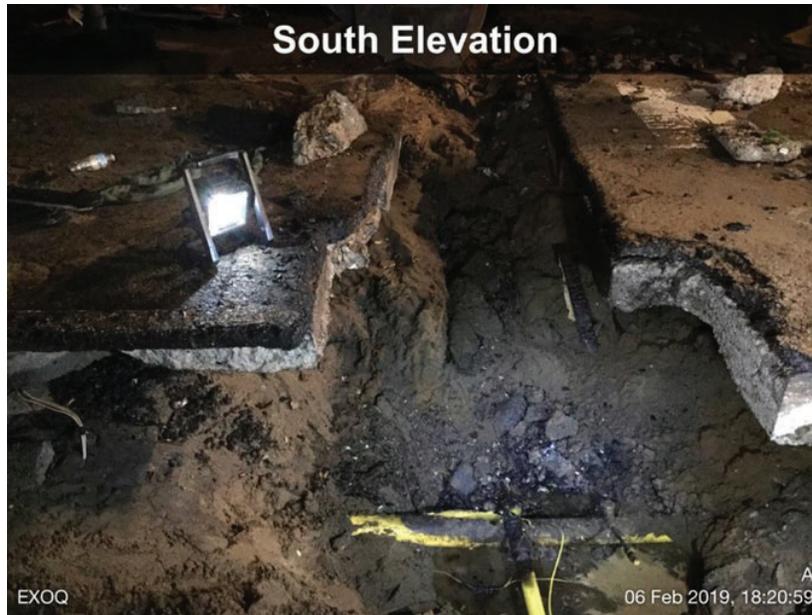
After the gas was shutoff and the fire was extinguished, PG&E later determined that a 4-inch plastic gas main had been damaged at the branch connection to a 2-inch plastic gas service line in the trench where the fire had started (**Figure 7**). An NTSB Materials Laboratory examination of the branch connection suggests that the bucket may have struck a polyethylene saddle-fused branch connection that likely extended above the 4-inch pipe 6.5 inches (**Exh 12**).

Figure 7: (from **Exh 13**) Damage at branch connection. Courtesy PG&E.

fused saddle connection that extended above the connection by 6.5 inches, at approximately 35.5 inches in depth. The operator of the excavator believed that he had exposed the 2-inch and 4-inch lines at a depth of 48 inches and that he was working at a depth of 30 inches at the time of the strike.
