Gas Pipe Hit

Synopsis

CALIFORNIA DIG SAFE BOARD

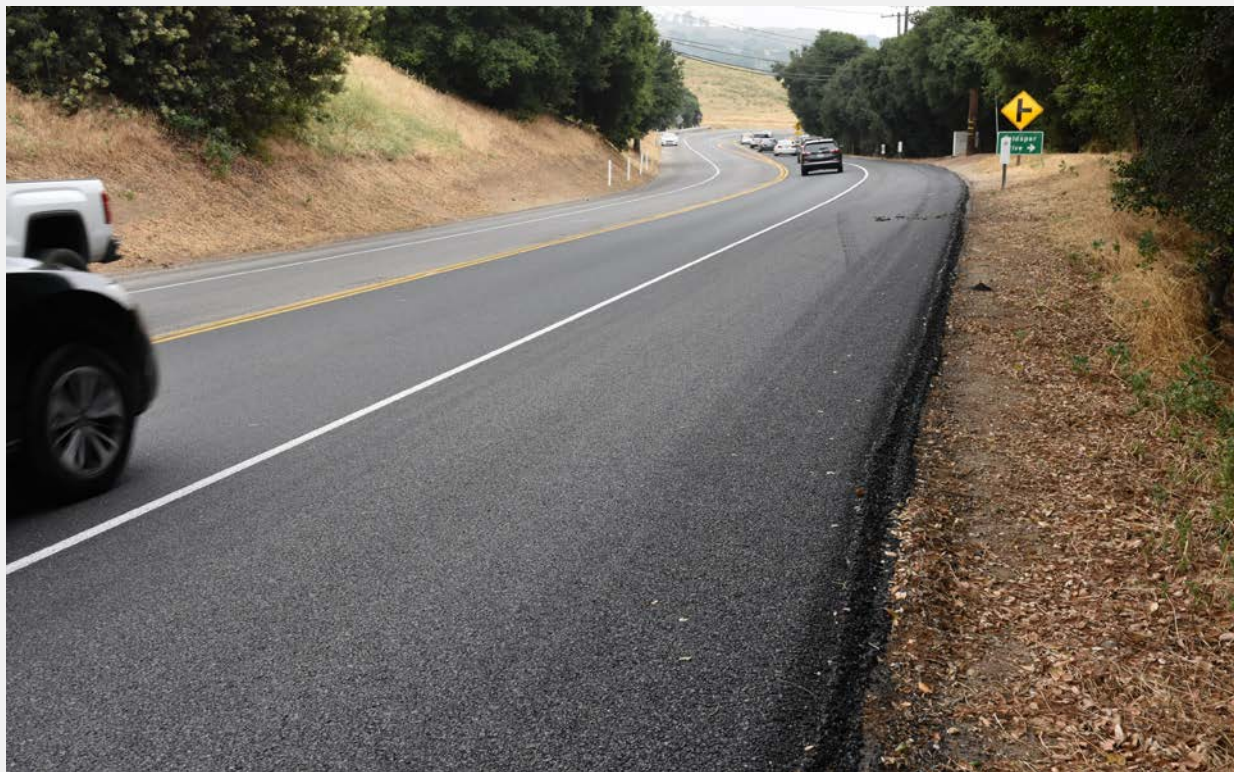
Incident roadside

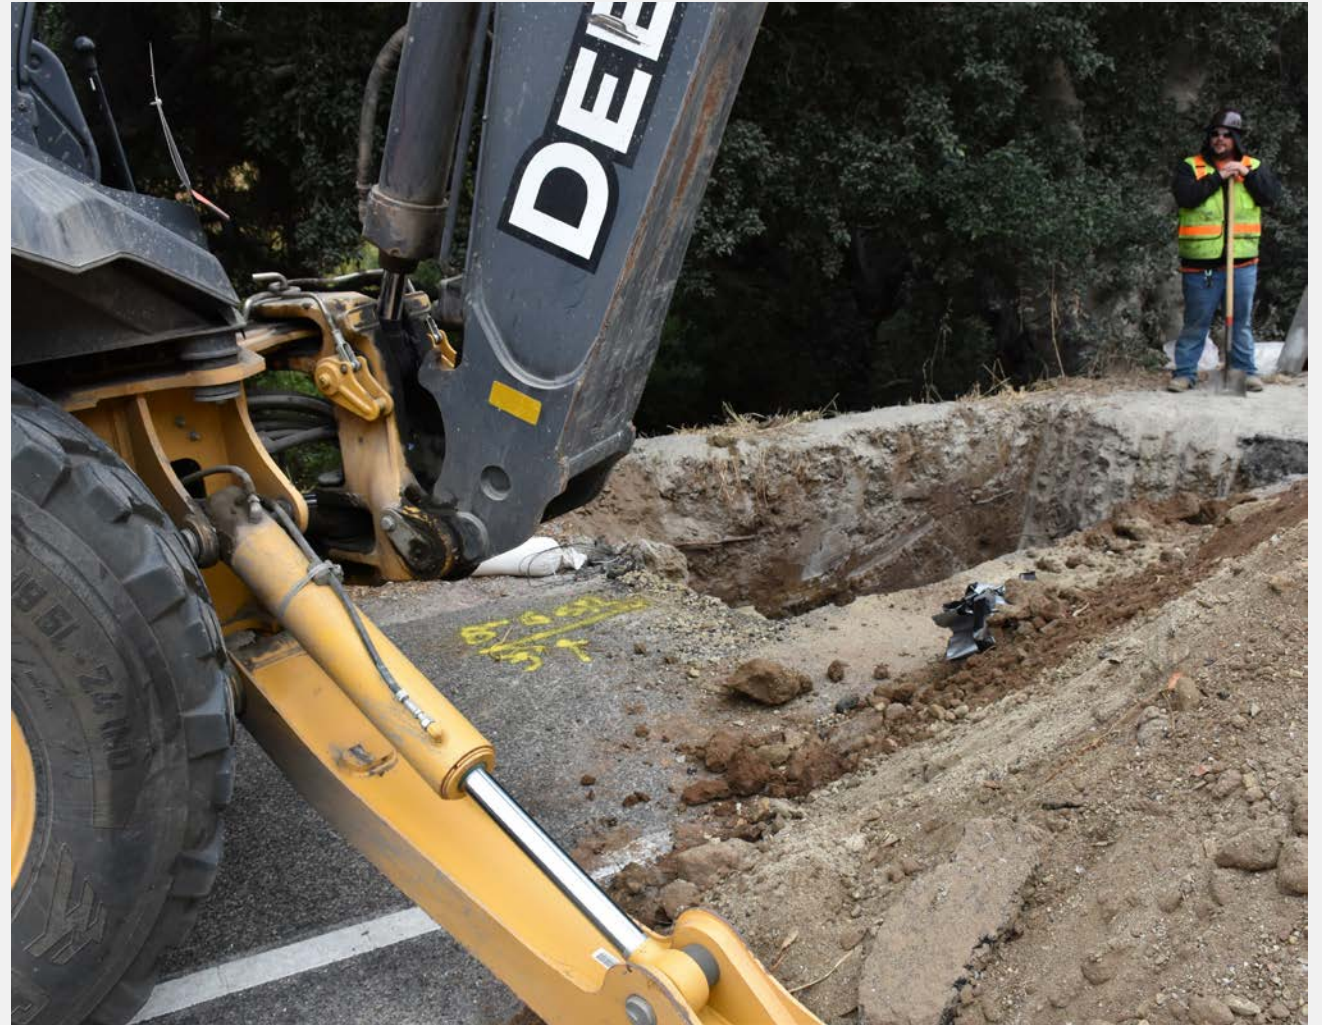
Hole dug up for repair

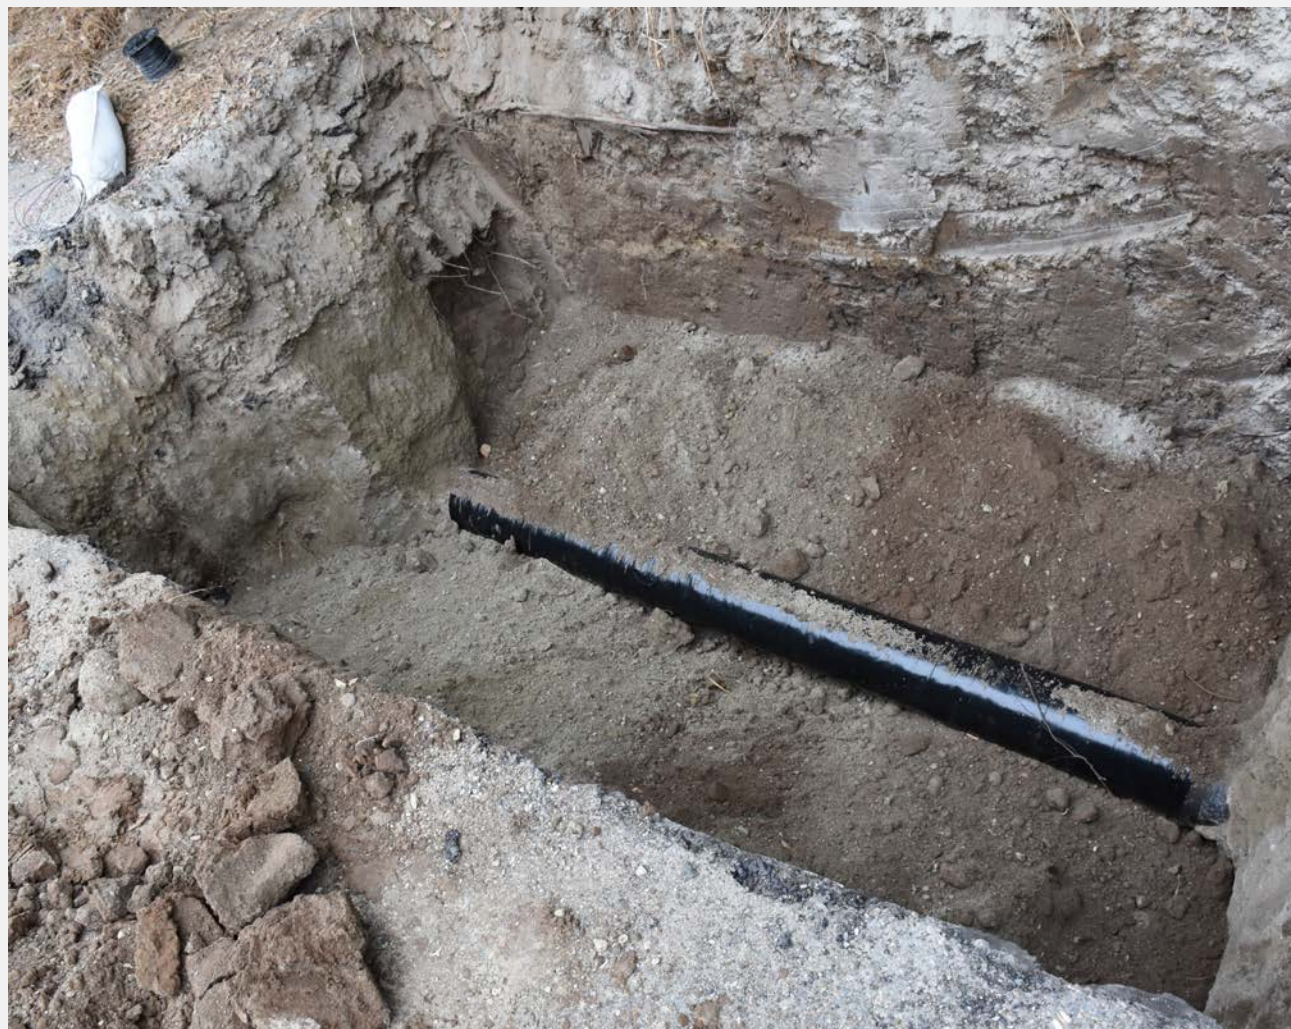
Repaired pipe

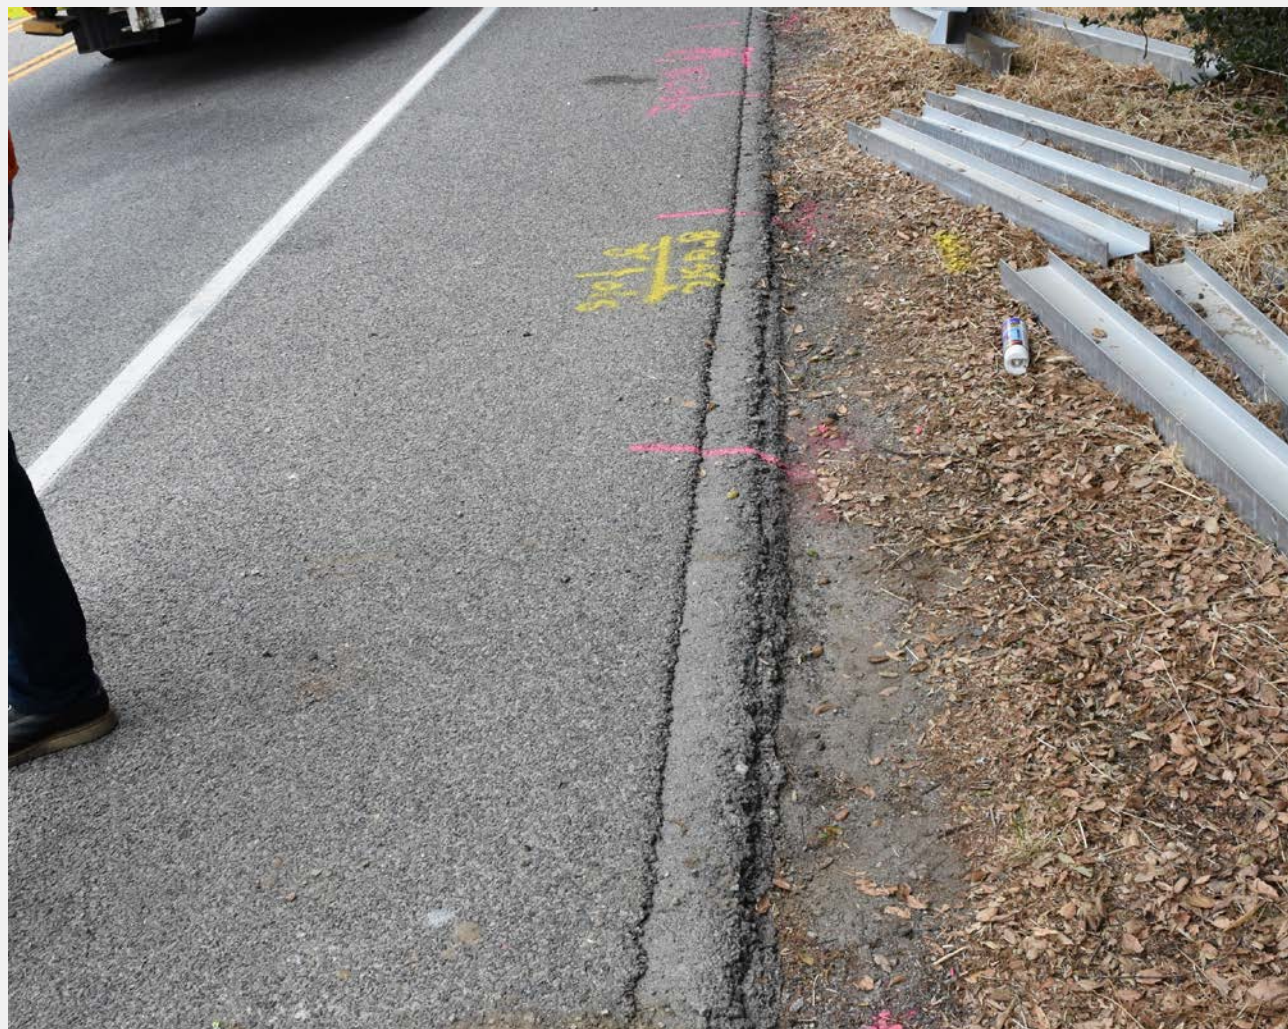
Pink interval marks for Excavator to dig holes for guardrail posts

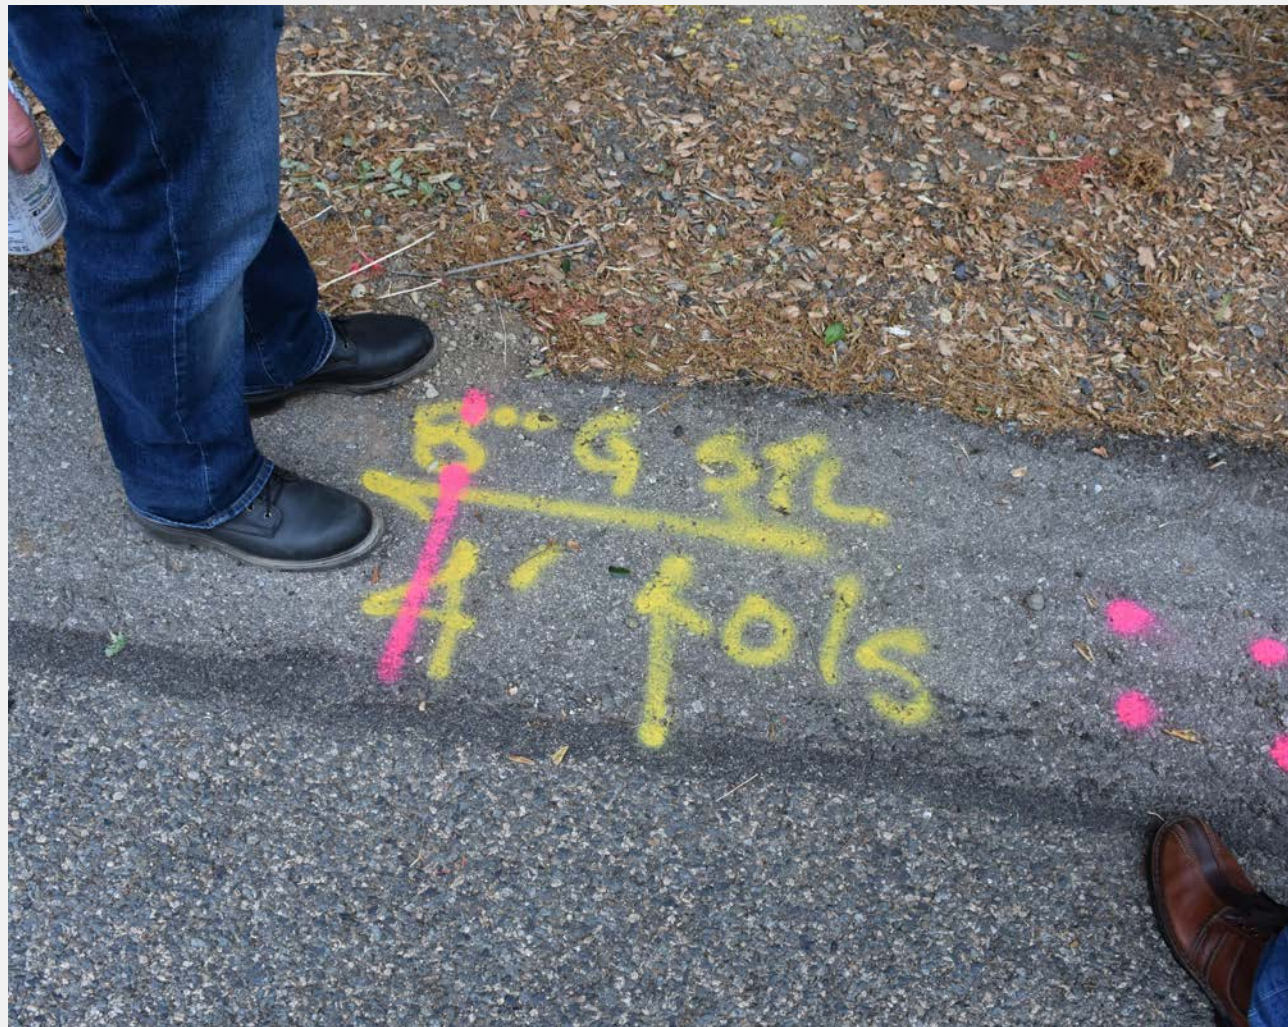
Excavator's pink mark sprayed over existing operator mark

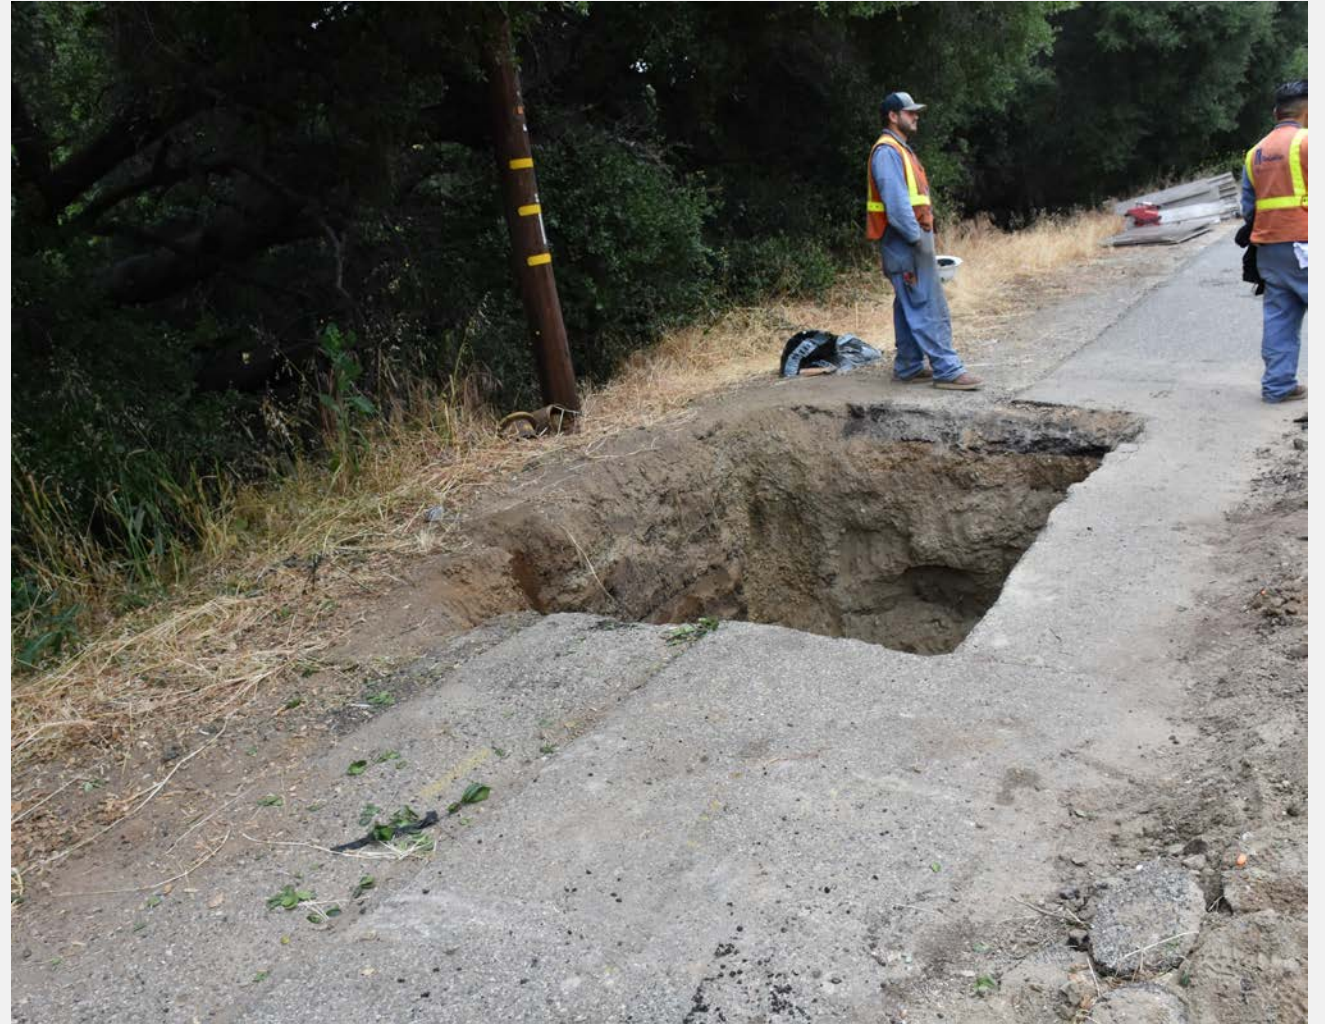
Gas pipe running right below the edges where asphalt meets the dirt

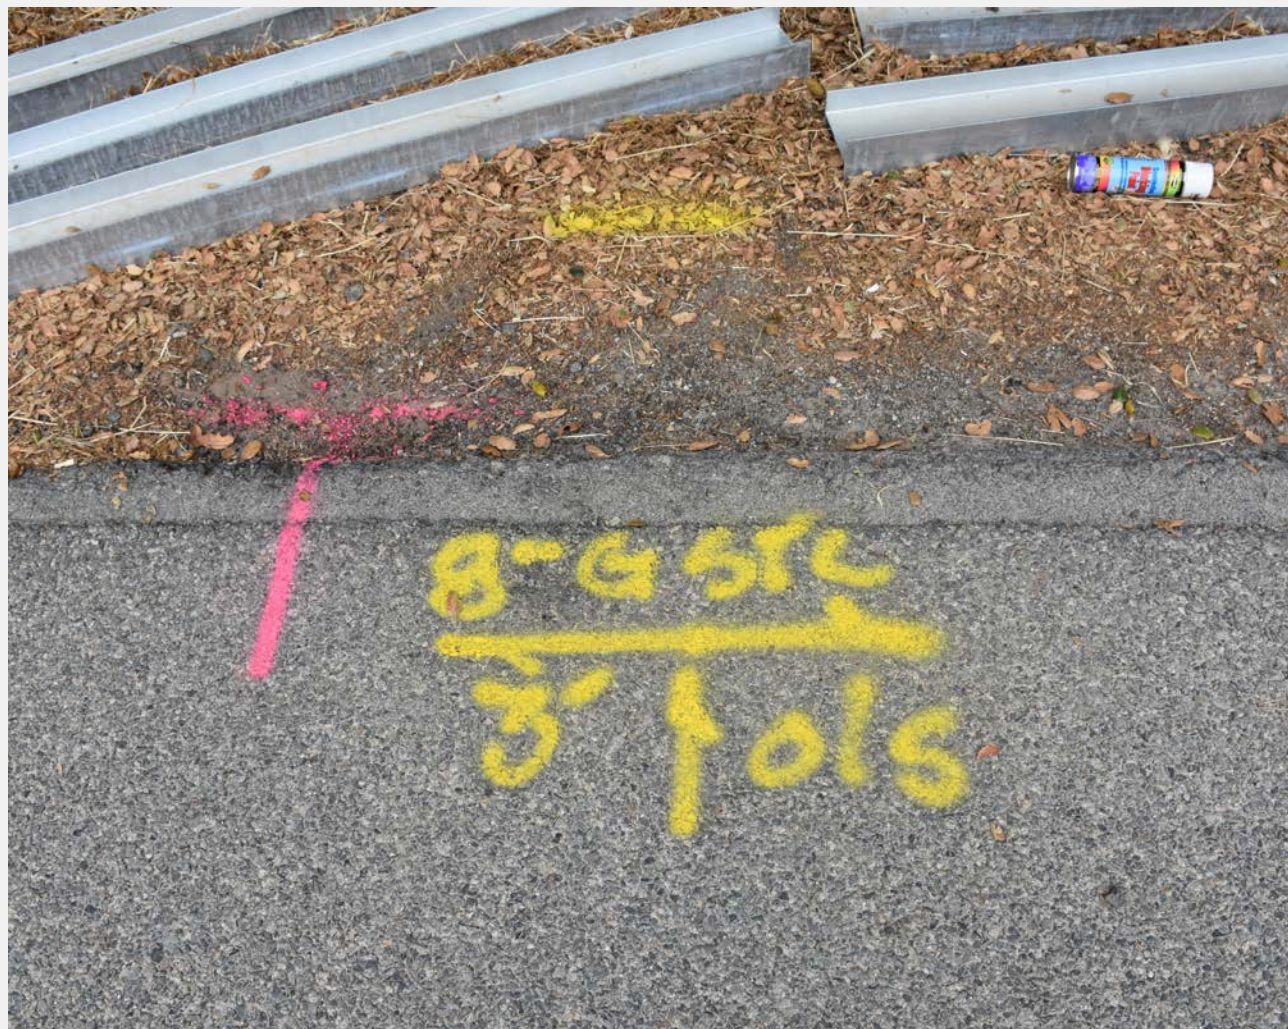
Operator locator mark at or near the edges where asphalt meets the dirt and Excavator pink marker with "T" where a hole should be dug up for guardrail posts

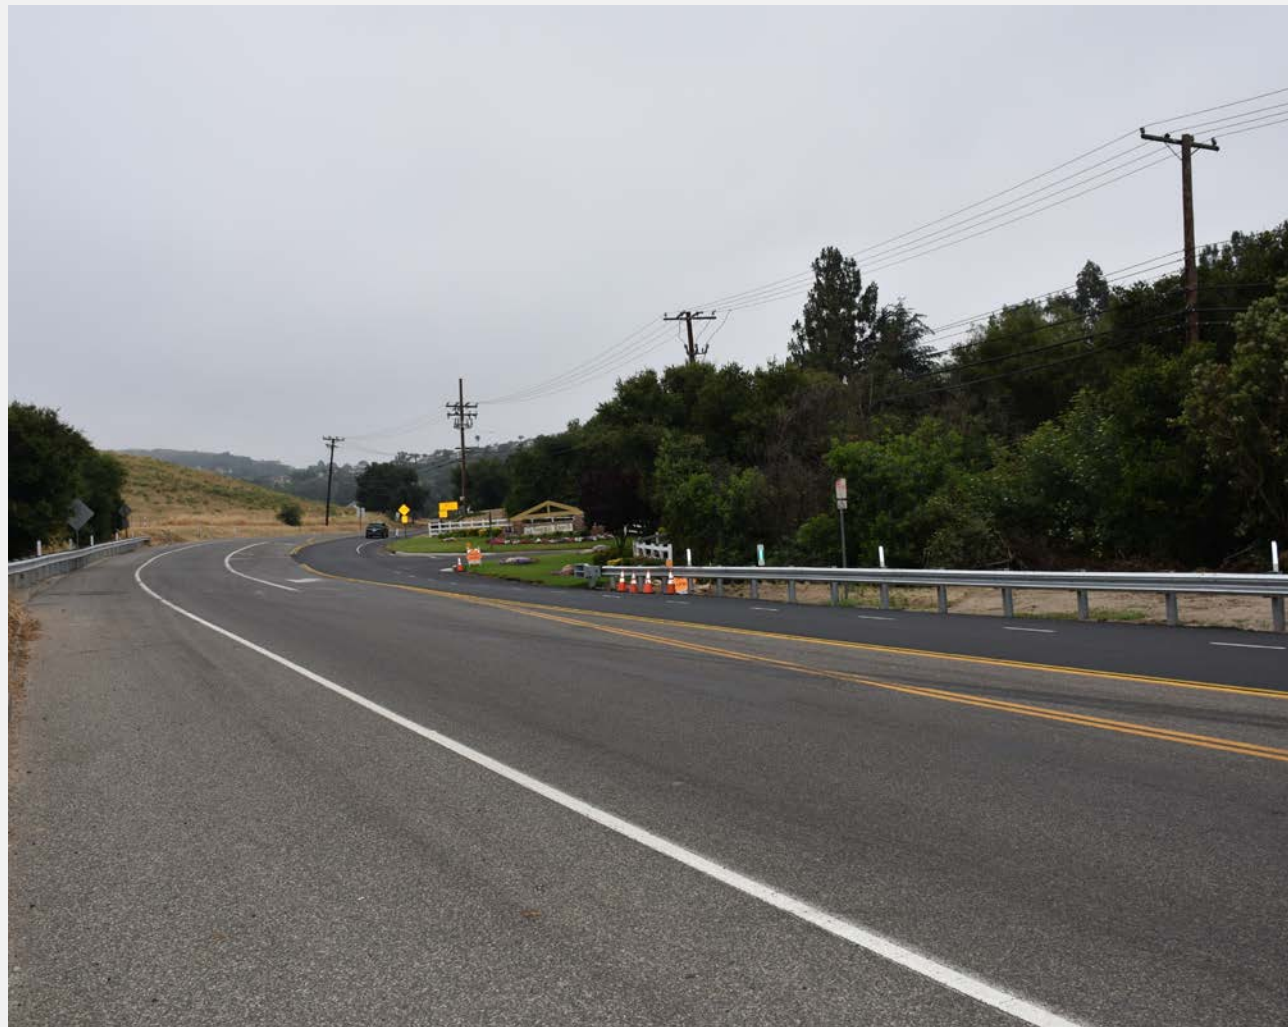
New guardrails installed on the side of road where the asphalt meets the dirt but the gas pipe below offset away from the edge at this particular area

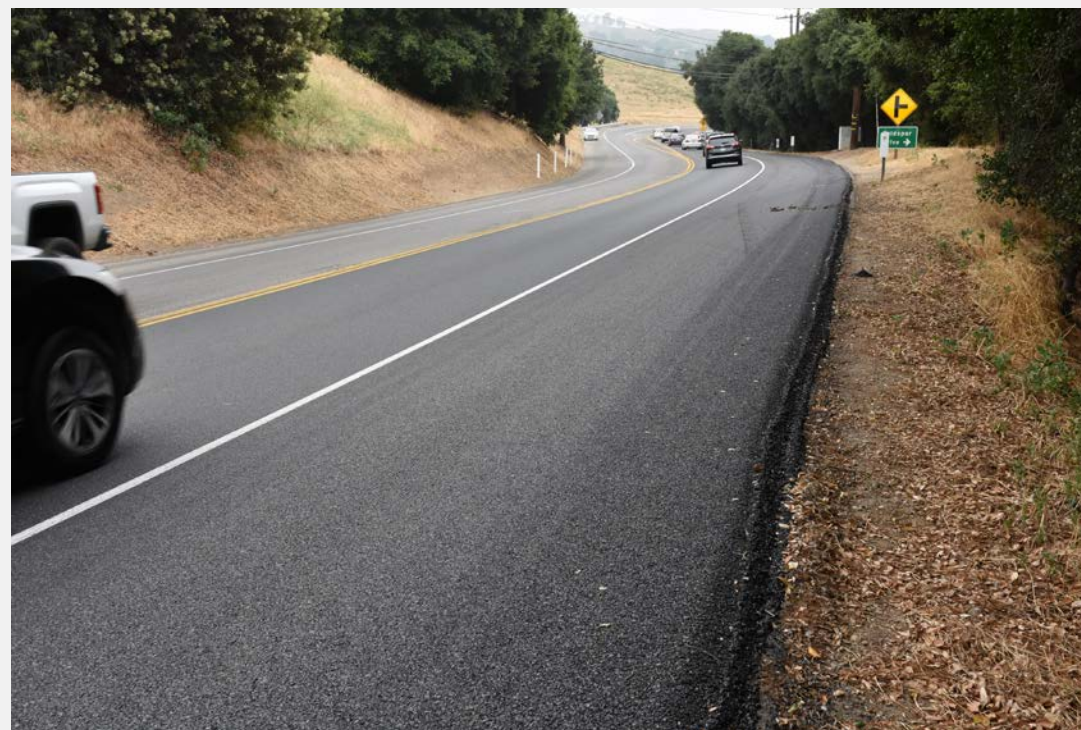
After the incident, new guardrails remain uninstalled at the edge where asphalt meets the dirt as the gas pipe runs right below it

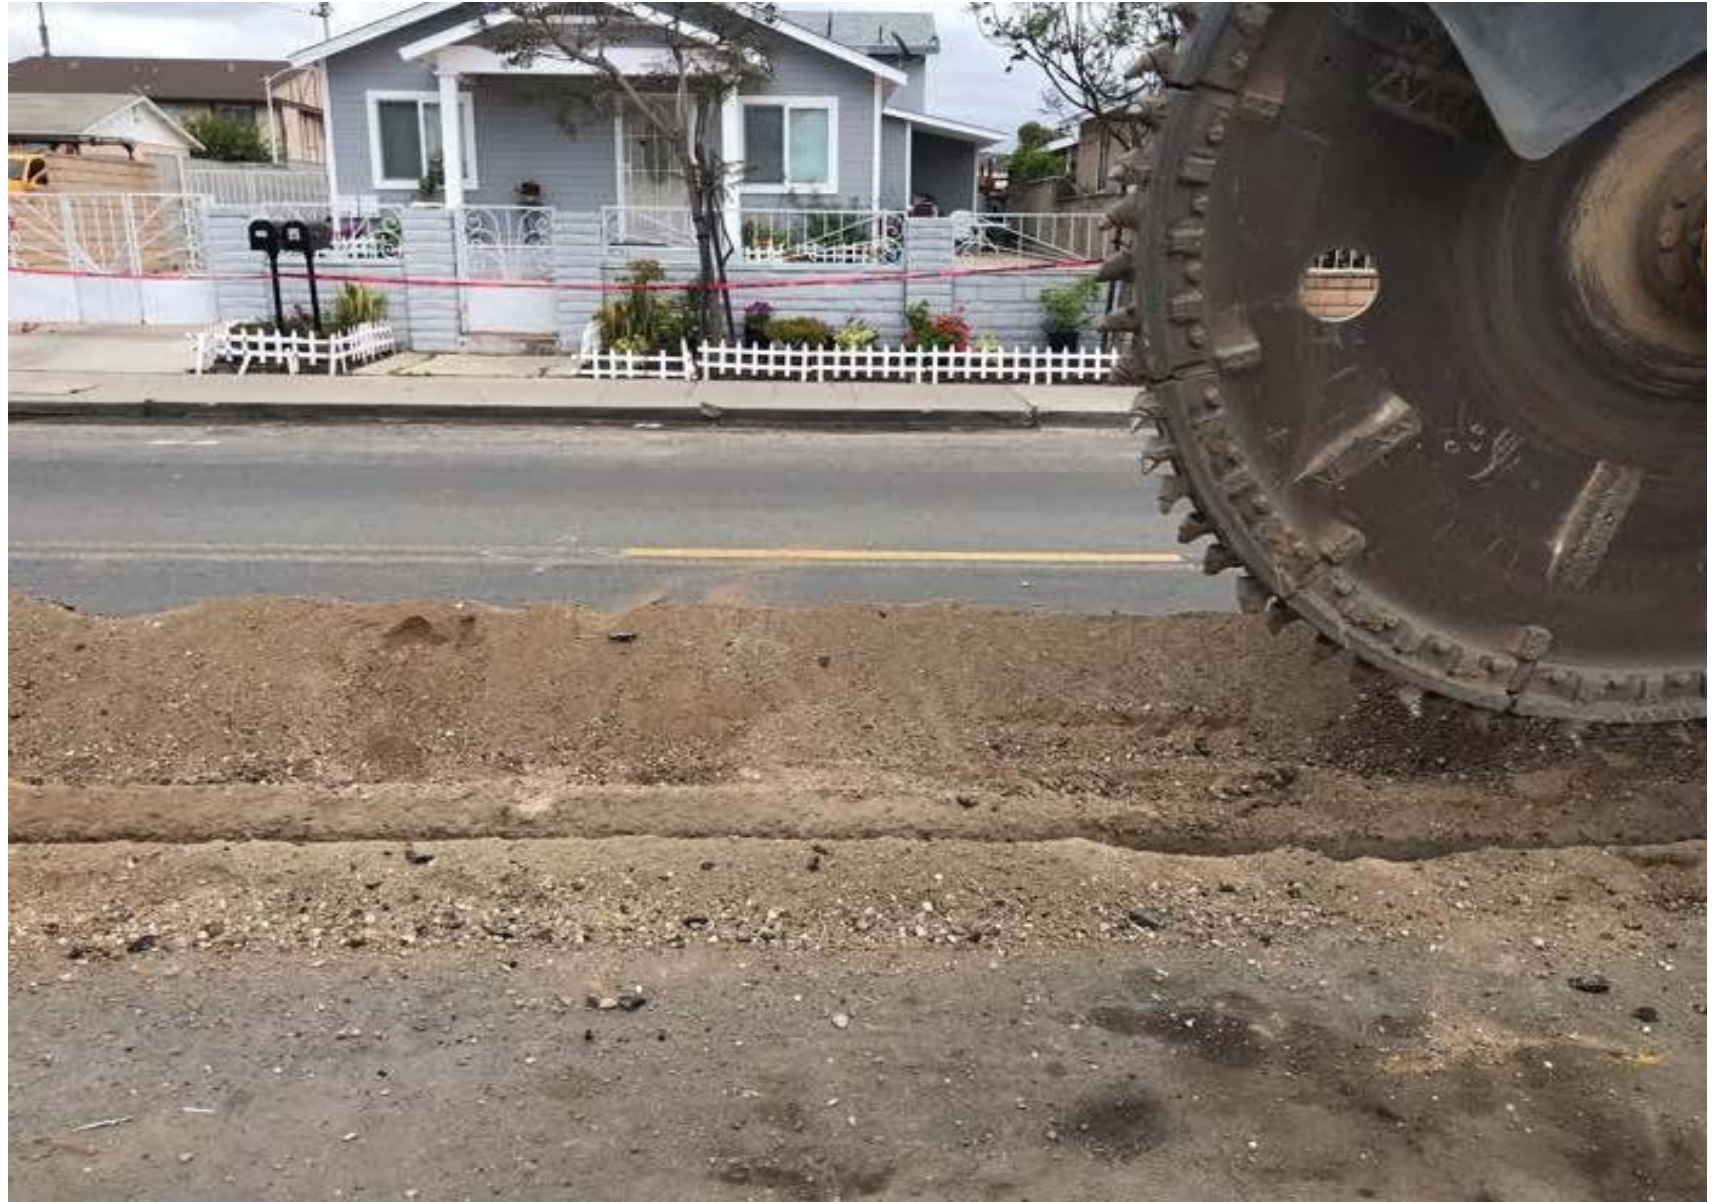
Cut was about 6
feet parallel from
the sidewalk

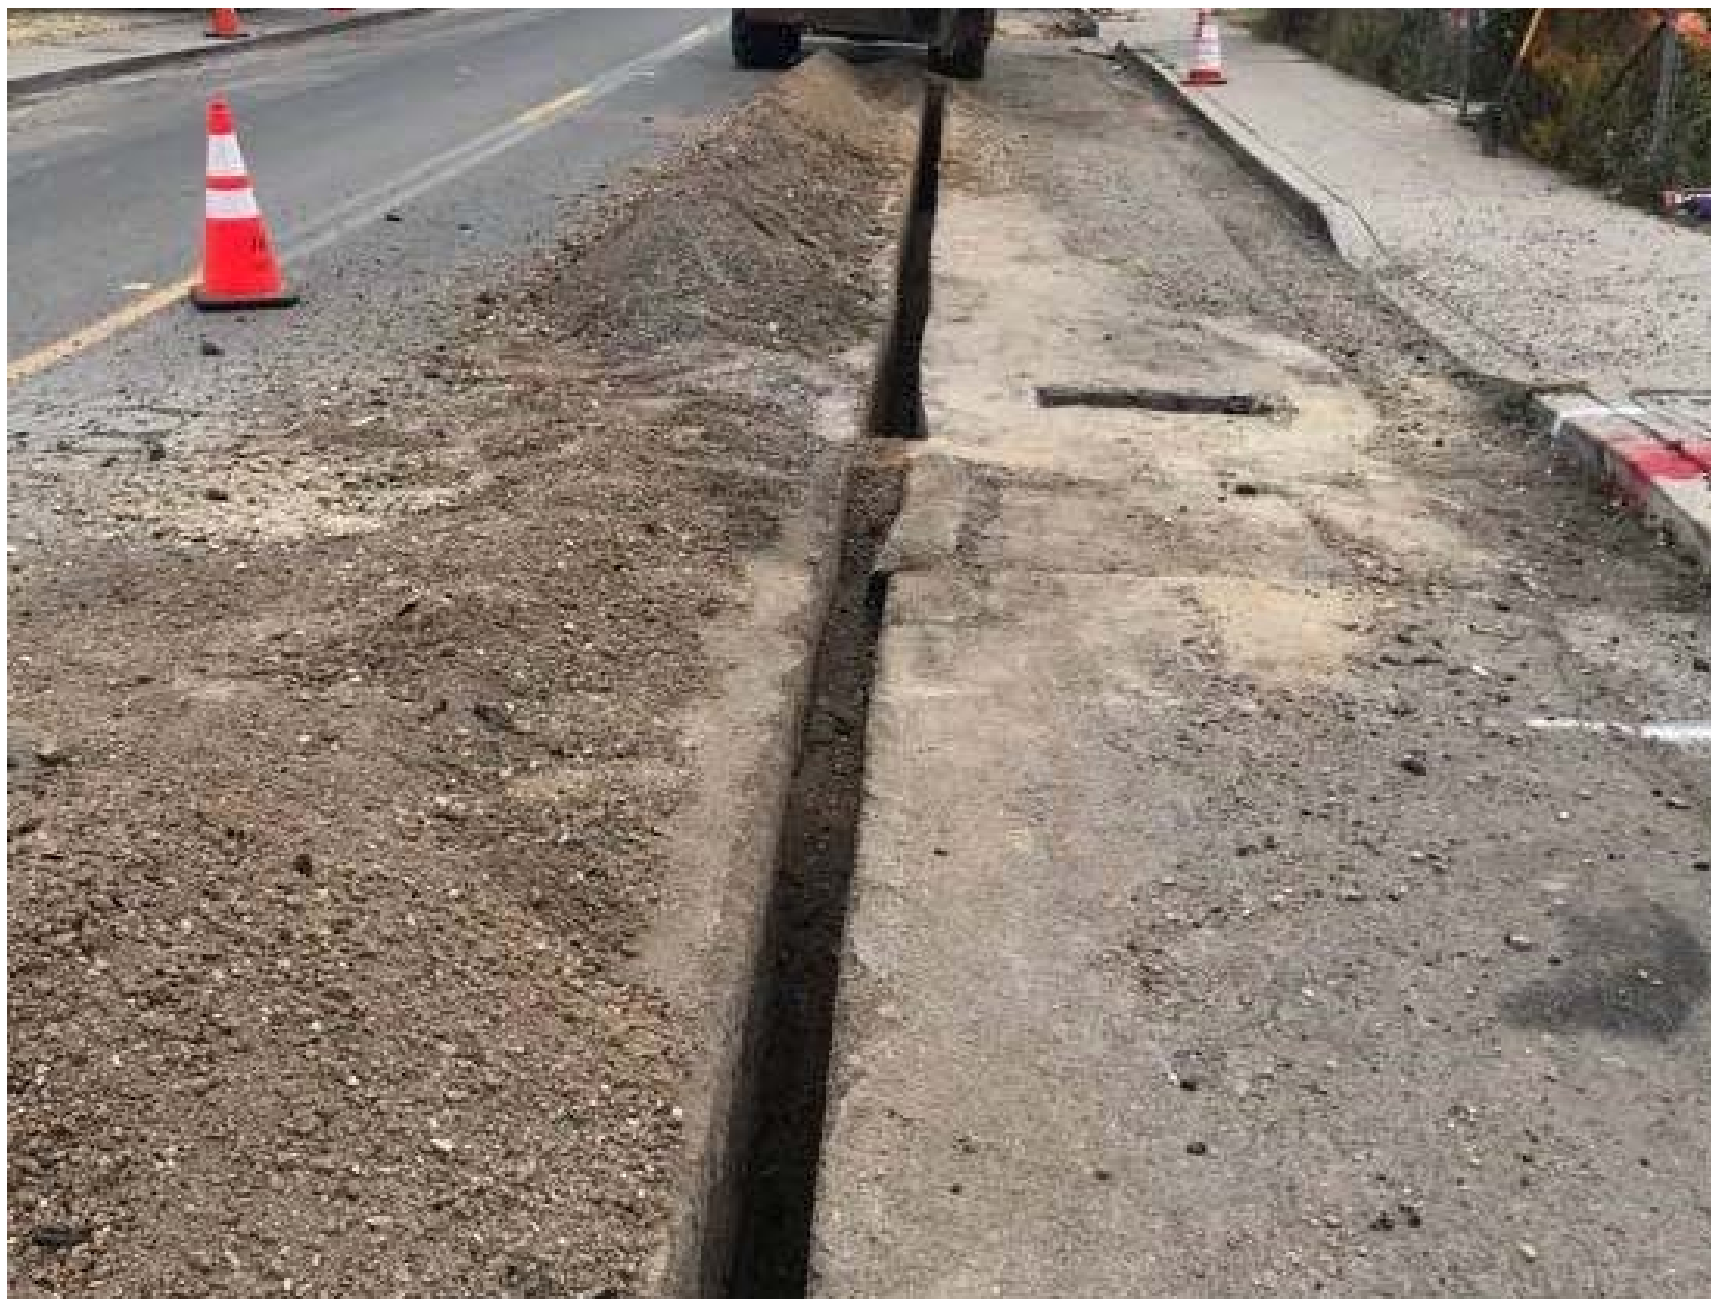
½ inch plastic
service gas line
was damaged

Excavation was
about 36 inches
deep

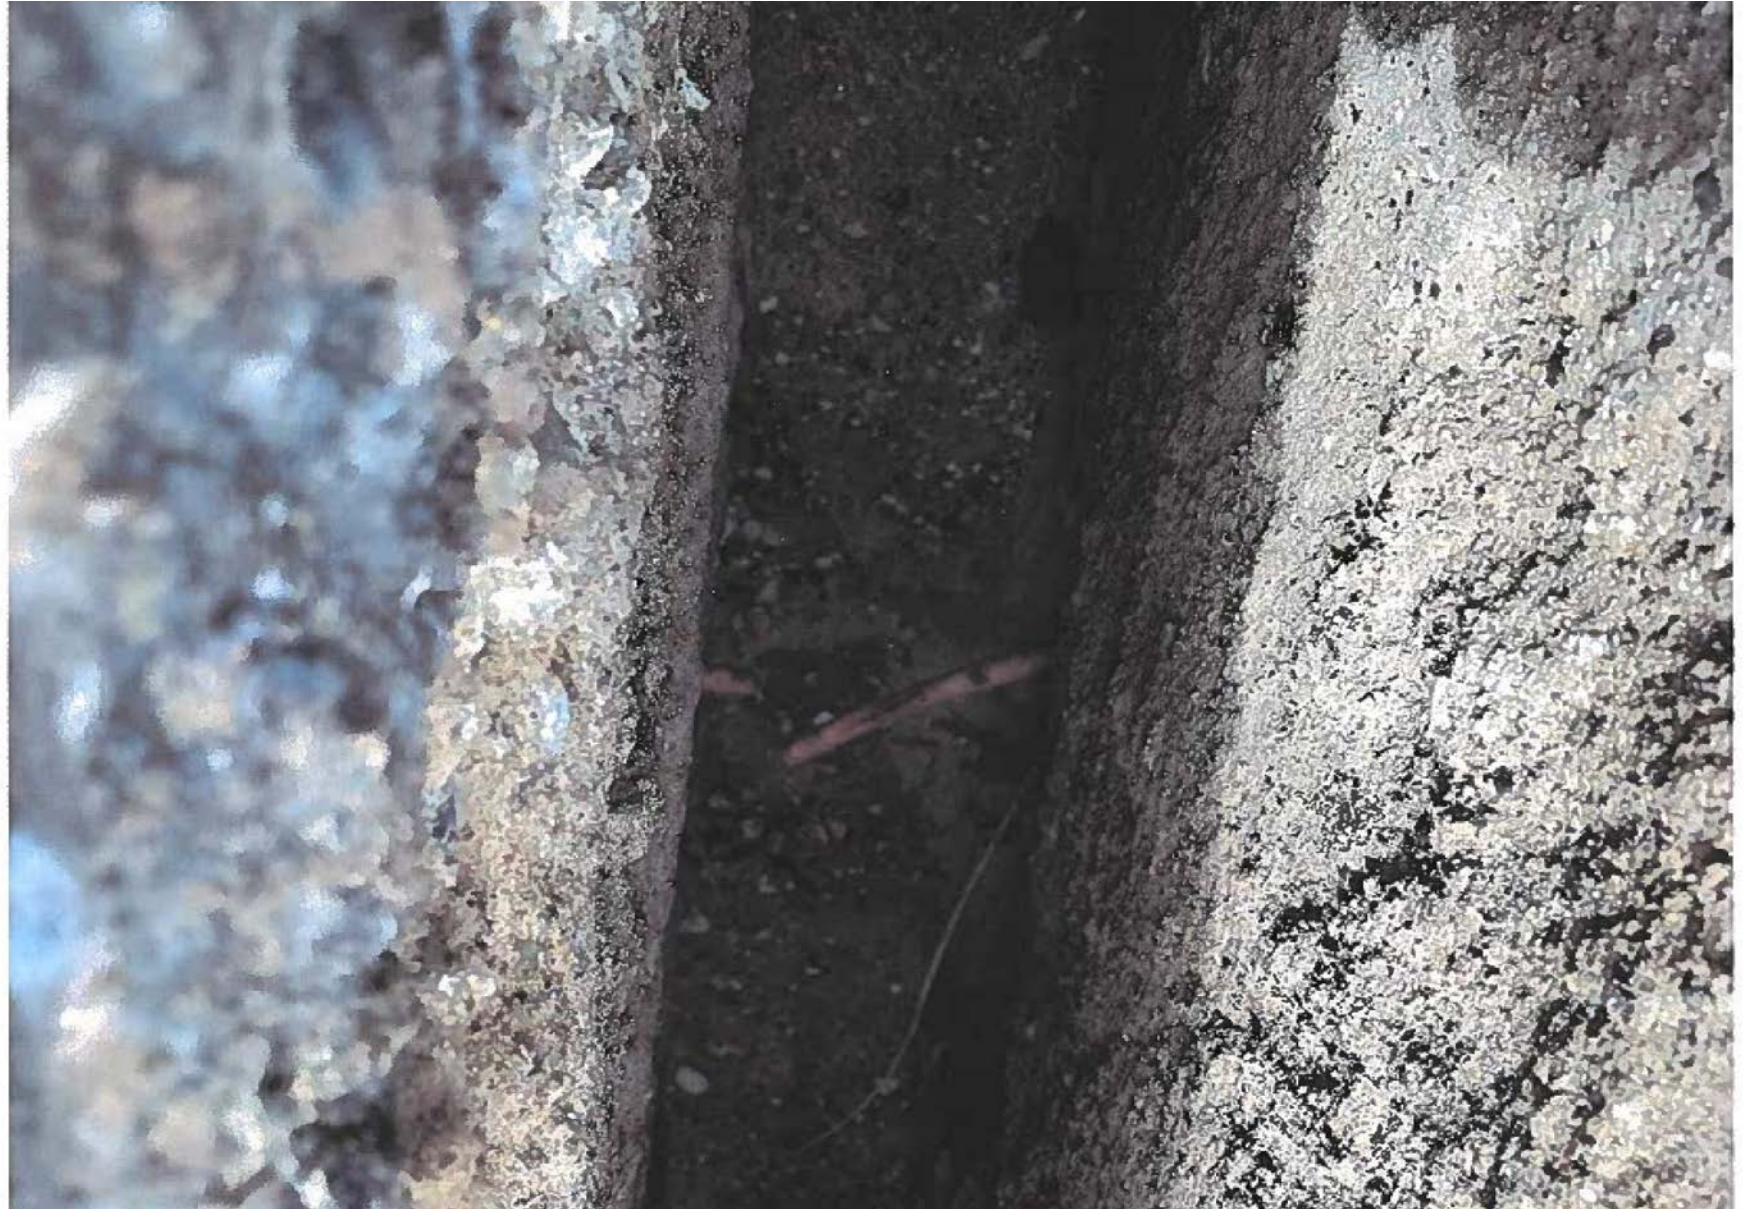
Hit was about
32 inches from
the closest
marked gas
line
