Oxnard Dig-in Incident

Safety and Enforcement Division

Electric Safety and Reliability Branch

July 13, 2021

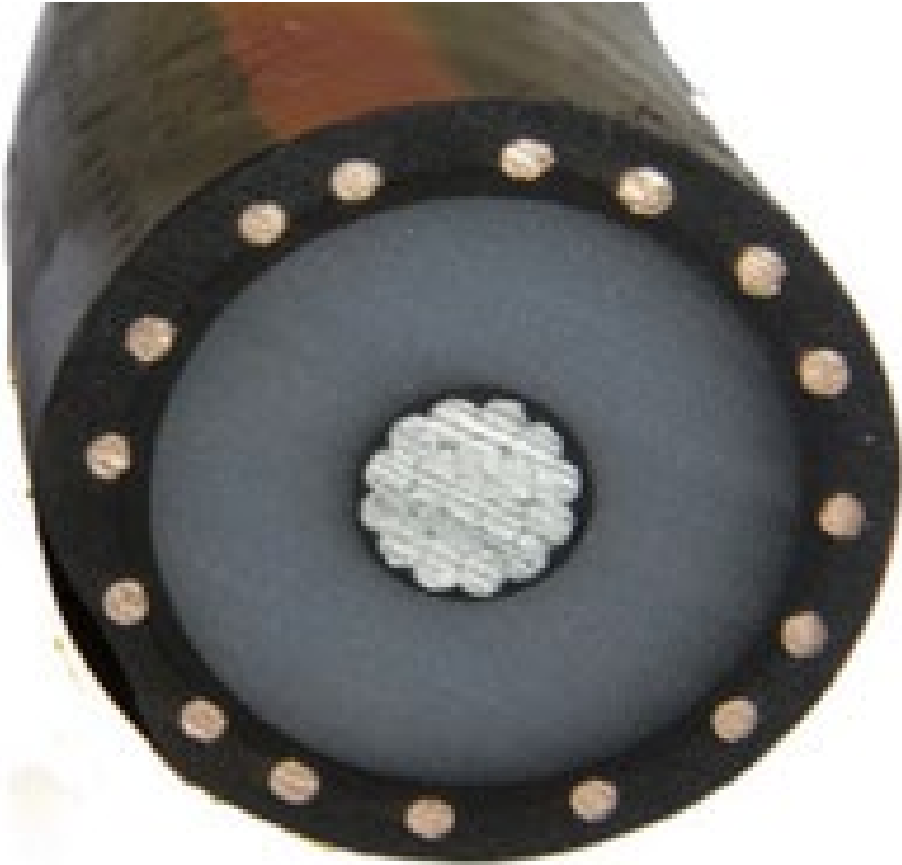
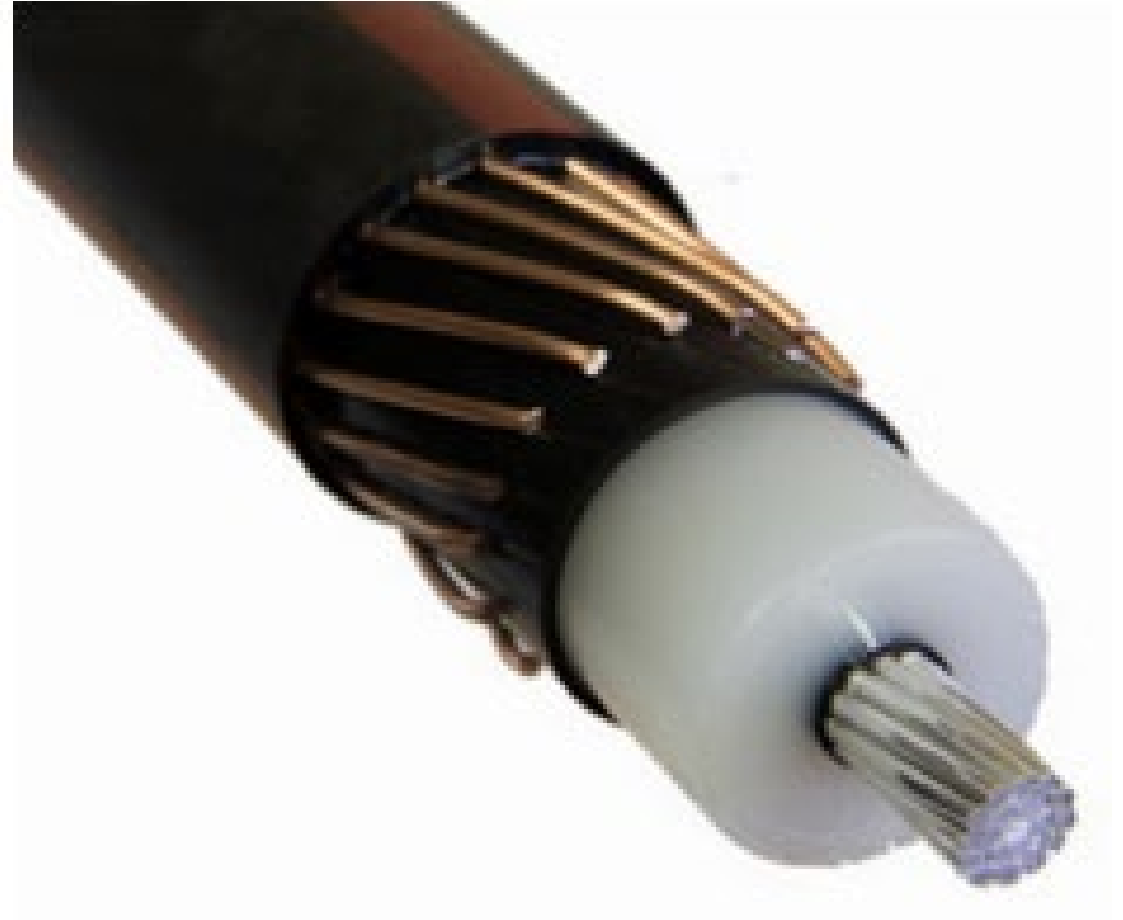
Underground Concentric Cable

- On November 28, 2017, SCE installed the new underground conductor.
- Due to delays, no excavation activity had yet begun.
- SCE did not mark the location of the new conductor.
- McCarthy Companies did not notify Baja Construction of the new conductor.
- SCE also did not notify UtiliQuest of the newly installed conductor.

- On December 2, 2017, Baja Construction began excavation activities.
- A Baja Construction employee exposed and damaged the conduit while digging with an auger.
- Baja Construction staff sought the expertise of a Light & Power, Inc. Foreman Electrician.
- Despite the new condition of the conductor, the new conduit, the visible trench marks, and the new padmounted transformer, the employee determined that the conductor was most likely inactive and cut it with a hand-held tool.
