**CALIFORNIA UNDERGROUND FACILITIES SAFE EXCAVATION BOARD
INVESTIGATION DIVISION
INVESTIGATION REPORT**

DATE: January 3, 2022

CASE No.: 20SA01279

Excavator struck natural gas distribution branch connection in downtown San Francisco, causing a release of gas, which subsequently ignited.

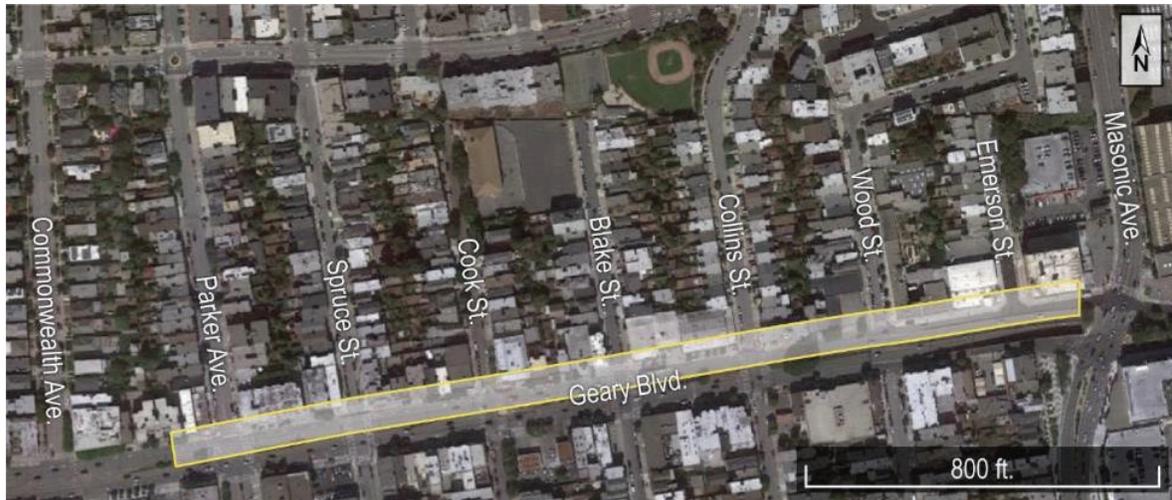
The project extended from 3310 Geary Boulevard to the intersection of Geary Boulevard and Masonic Avenue (See **Figure 1**). The project was segmented into 13 subprojects, each about one-half block long. The first segment was from 3310 Geary Boulevard to the intersection of Geary Boulevard and Parker Avenue and involved installing three high-density polyethylene conduits along Geary, starting from a junction box west of Parker, and at Parker, two conduits would continue eastward along Geary (**Exh 5**, p. 20). This phase of the project was limited to 180 feet along Geary and north on Parker for 50 feet past the crosswalk (**Exh 6**).

Figure 1: Work project area. Courtesy NTSB.

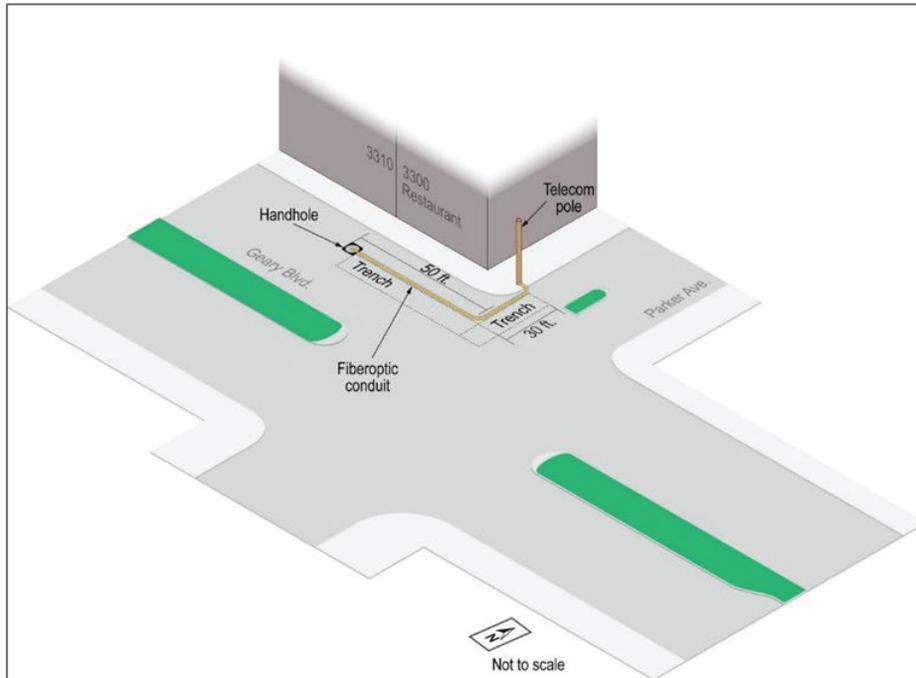
On February 6, 2019, Kilford employees arrived at the site around 7:30 a.m. and held a safety briefing (**Exh 9**). Once traffic control was in place, excavation work began about 9:00 a.m. The work plan for that day was for three lines of conduit to be placed along Geary Boulevard 50 feet west of the intersection with Parker Avenue, at a new handhole and run to the intersection where one of the three lines of conduit would then run north along Parker Avenue to a telecommunications pole (**Figure 3**).

Figure 3: Excavation work plan for 2/6/19. Courtesy NTSB.
