April 7, 2020

Wildfire Safety Division
California Public Utilities Commission

RE: Comments and Criticisms Regarding PG&E's WILDFIRE MITIGATION PLAN REPORT,
RULEMAKING 18-10-007 FEBRUARY 7, 2020

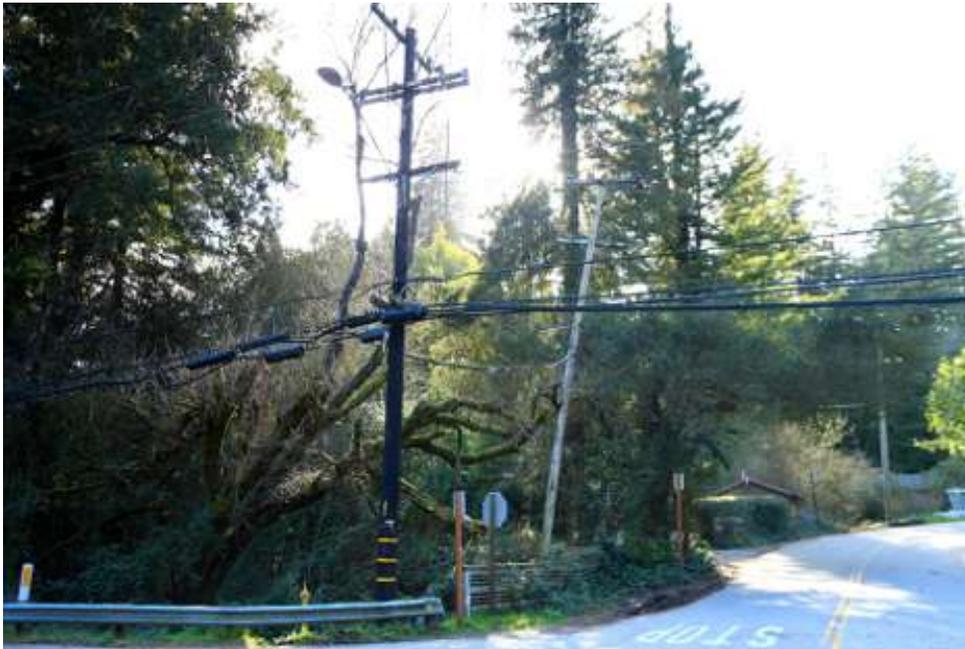
Power pole leading up a small street off of State Route 9 in Felton, CA, is tilting and barely standing up. It carries a bare, uninsulated powerline.

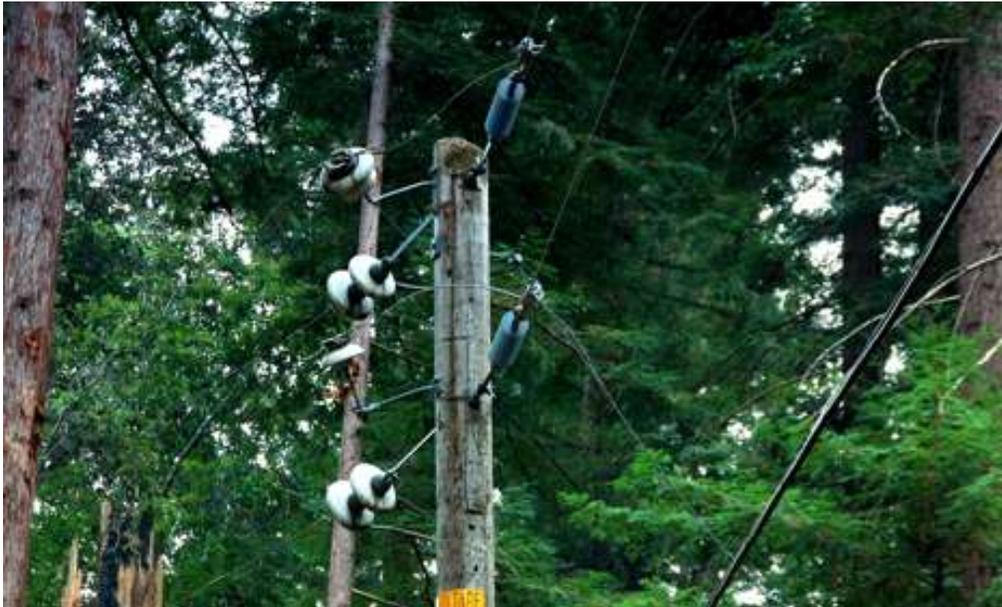
Pilger Rd. power line is antiquated and unsafe. Rather than replace it, PG&E cut down a dozen healthy, mature redwood trees to "protect" it.

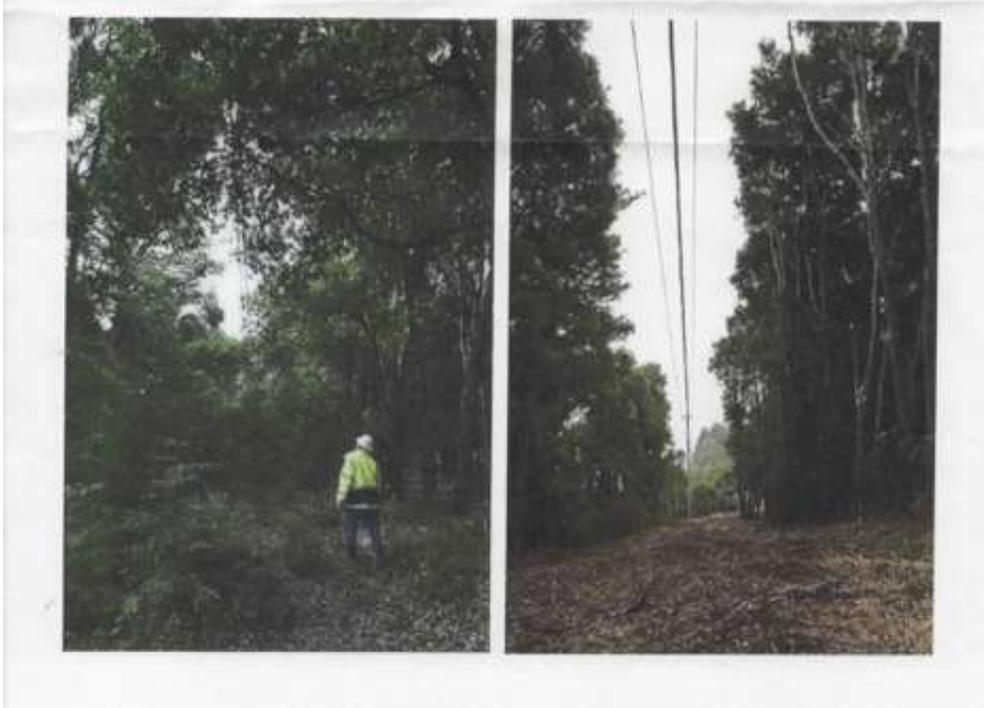
Extensive clearing under the wires is part of PG&E’s EVM. PG&E’s contractors were given photos of what they wanted the EVM to look like in the Santa Cruz Coastal Mountains. The long, flat area of the photo below has little relevance to the steep, highly erosive slopes in forested areas. When the CPUC self-declared the EVM “Exempt” from CEQA environmental review much was lost. It ignored the impacts of clearing approximately 80 times the area more than the “regular” 4-foot-radial to-last-a-year trim. Even PG&E did not realize the time and costs involved in removing that many trees and that much brush, so the job was rarely completed. **This is also a prime example of the creation of a wind tunnel like those that exacerbated the Paradise fire.**

This “before and after” EVM photo example of EVM was distributed to PG&E contractors by Rob Morse, Senior Manager, Central Coast Division in the summer of 2018.

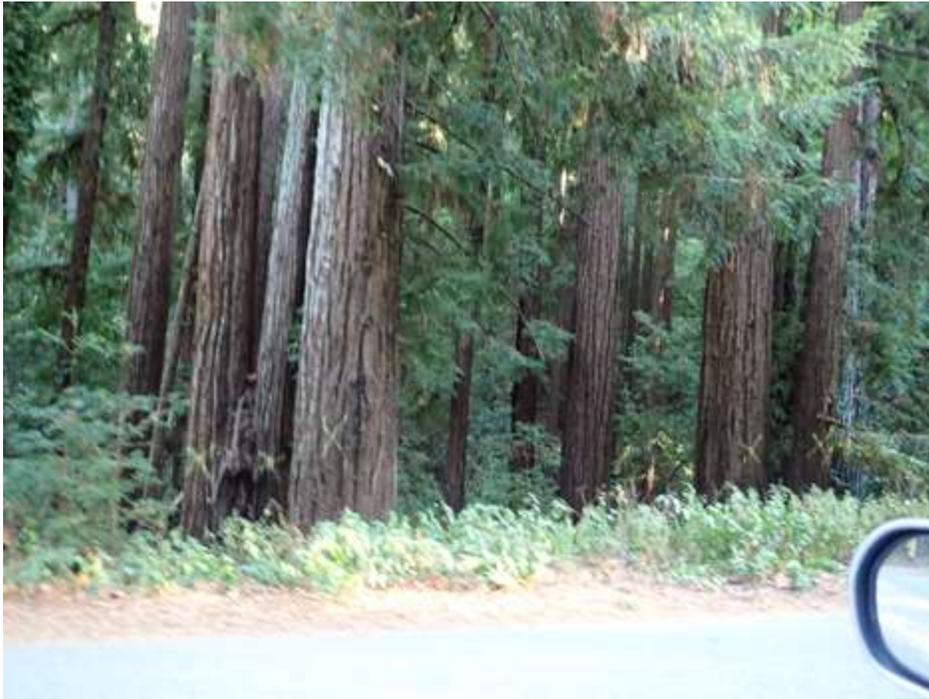
Hundreds of redwoods in the riparian corridor of Steelhead-valued **Two Bar Creek** marked with yellow X for removal. Riparian tree cutting increases the potential for soil erosion and streambank failure. Extensive riparian tree removal for extended distances in proximity and underneath these power lines in these settings will reduce stream shading and increase water temperature.
