NOTICE OF PROBABLE VIOLATION

Case No.: 20LA1086

**CALIFORNIA UNDERGROUND FACILITIES SAFE EXCAVATION BOARD
INVESTIGATION DIVISION
INCIDENT INVESTIGATION REPORT**

Case Number: 20LA1086	Report Date: August 20, 2020
Subject Name: Southern California Gas Company	Notification Date: February 4, 2020

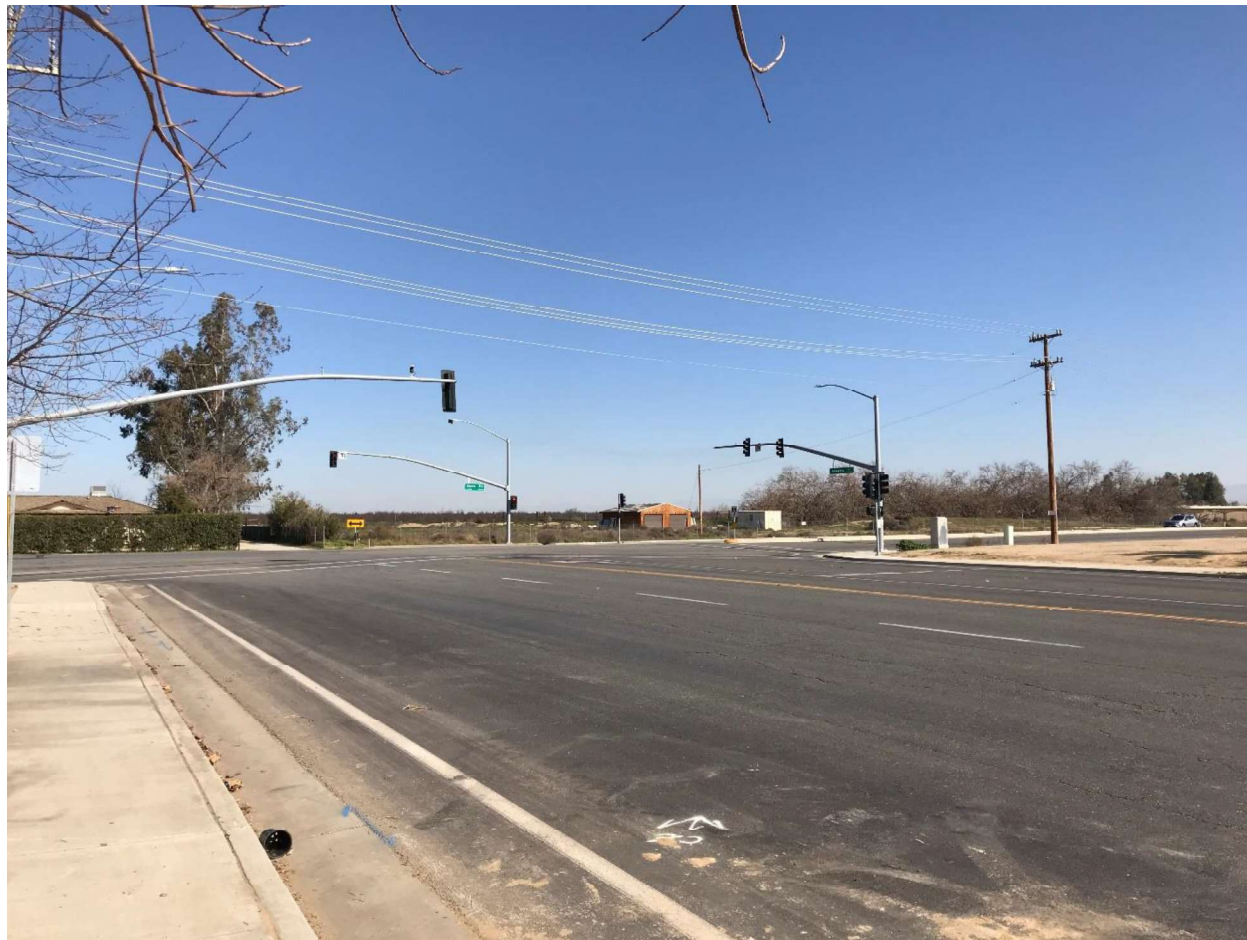
Photo 1

On February 10, 2020, I visited the incident site and took photos of the area. (**Photo 1, 2, 3, 4**).

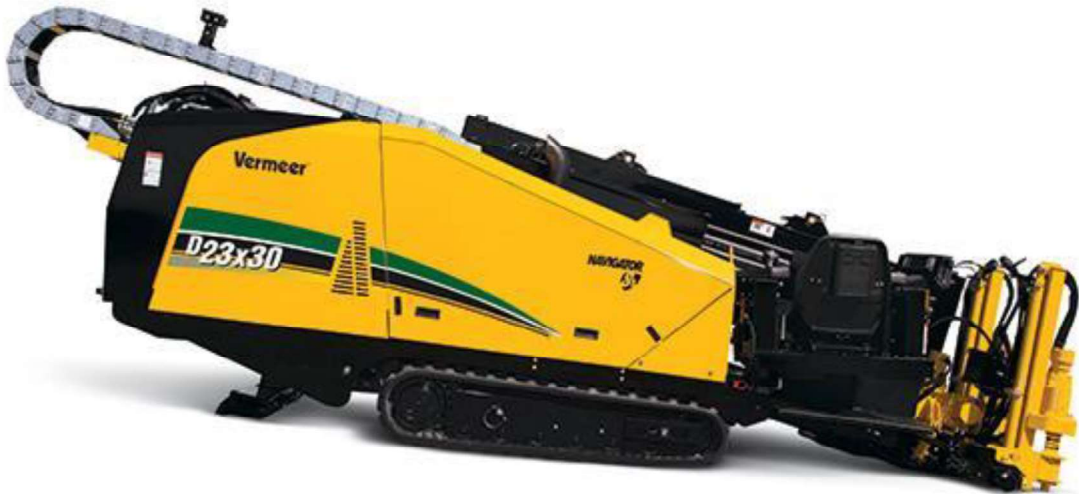
Image 2

CCE commenced work on or about February 3, 2020 at or around 1130 hours. One of its Vermeer directional drills (**Image 2**) made a contact with a six-inch plastic gas main and bored through it (**Photos 5, 6, 7, 8, 9**).

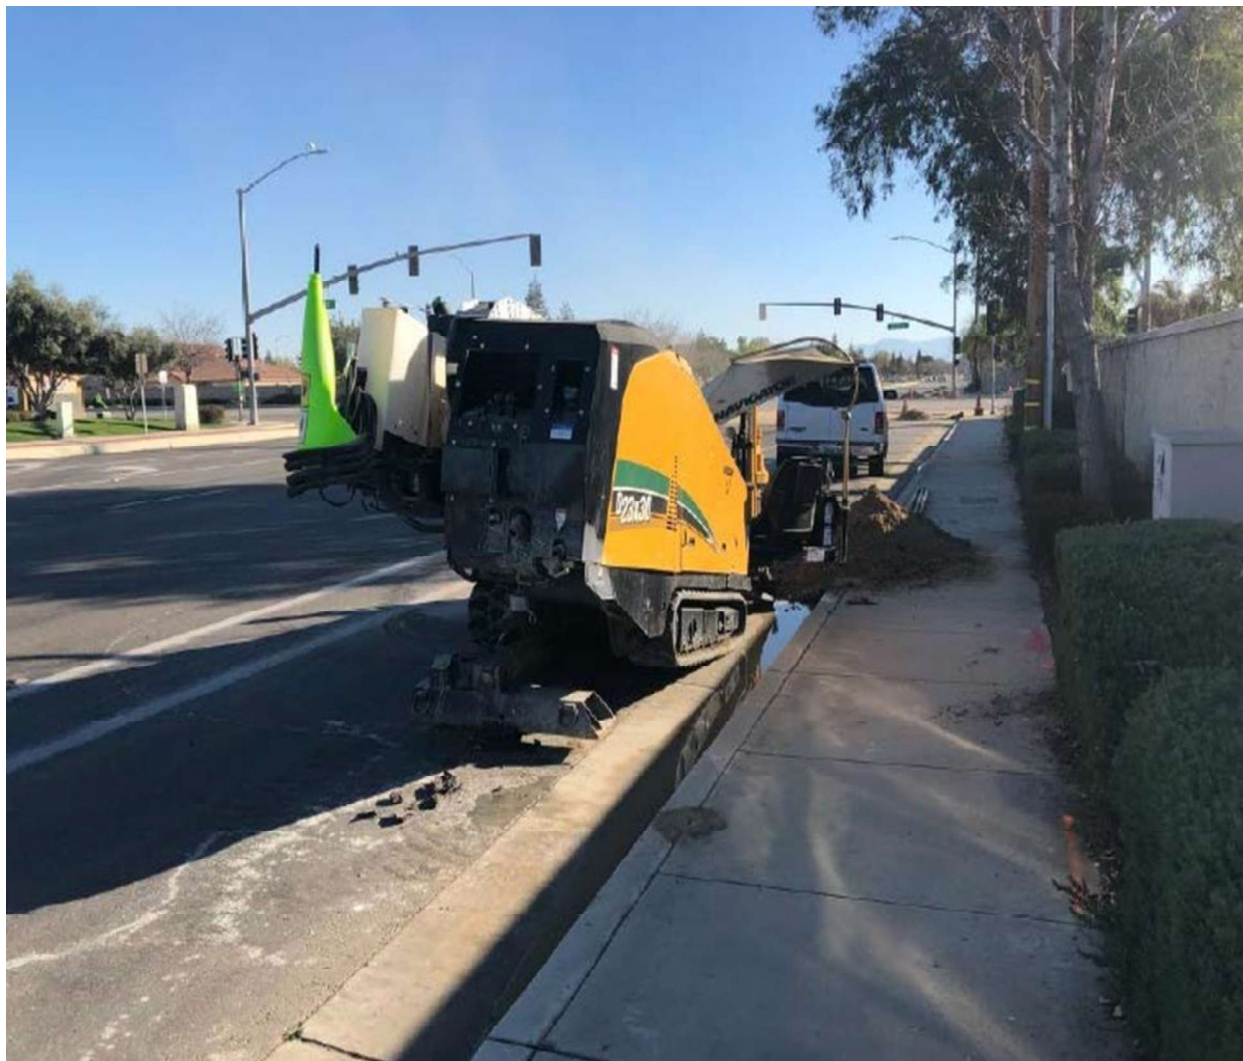
Photo 5: Directional Drill made contact with six-inch gas main

SCGC's locator did not complete the markings, yet indicated the job was completed on the operator's KORTERRA System. Because CCE does not have access to the KORTERRA System and SCGC does not use electronic positive response yet, CCE commenced excavation based on the presence of SCGC markings as well as the fact that the legal start date had passed. As a result, on February 3, 2020, the excavator made contact with and bored through a six-inch gas pipeline causing a gas release. Nearby neighborhoods were evacuated; the area was blocked off and the traffic rerouted as a precaution. The operator repaired the gas pipeline damage. There was no gas supply outage to affected customers as a result of this incident. Gas flow was ceased February 3, 2020 at 1630 hours and restored on February 4, 2020 at 0351 hours.

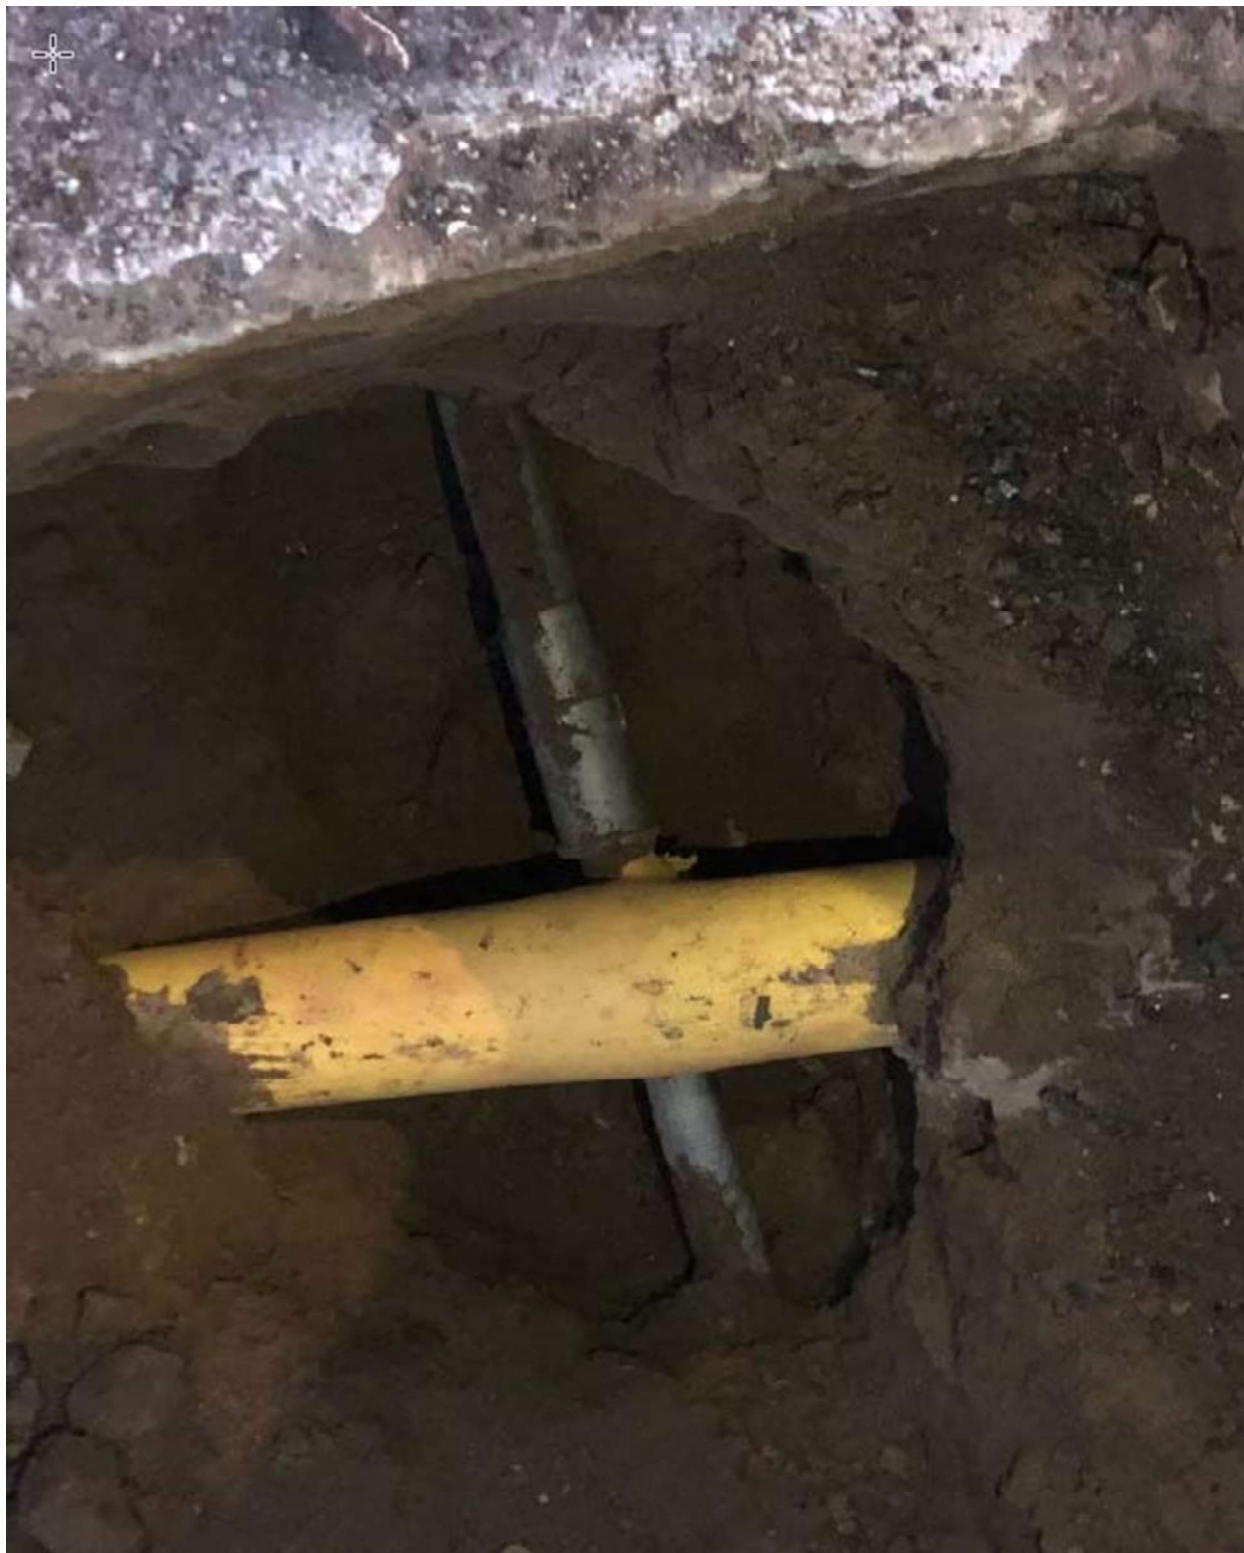
Photo 6: Directional Drill bored through the six-inch gas main

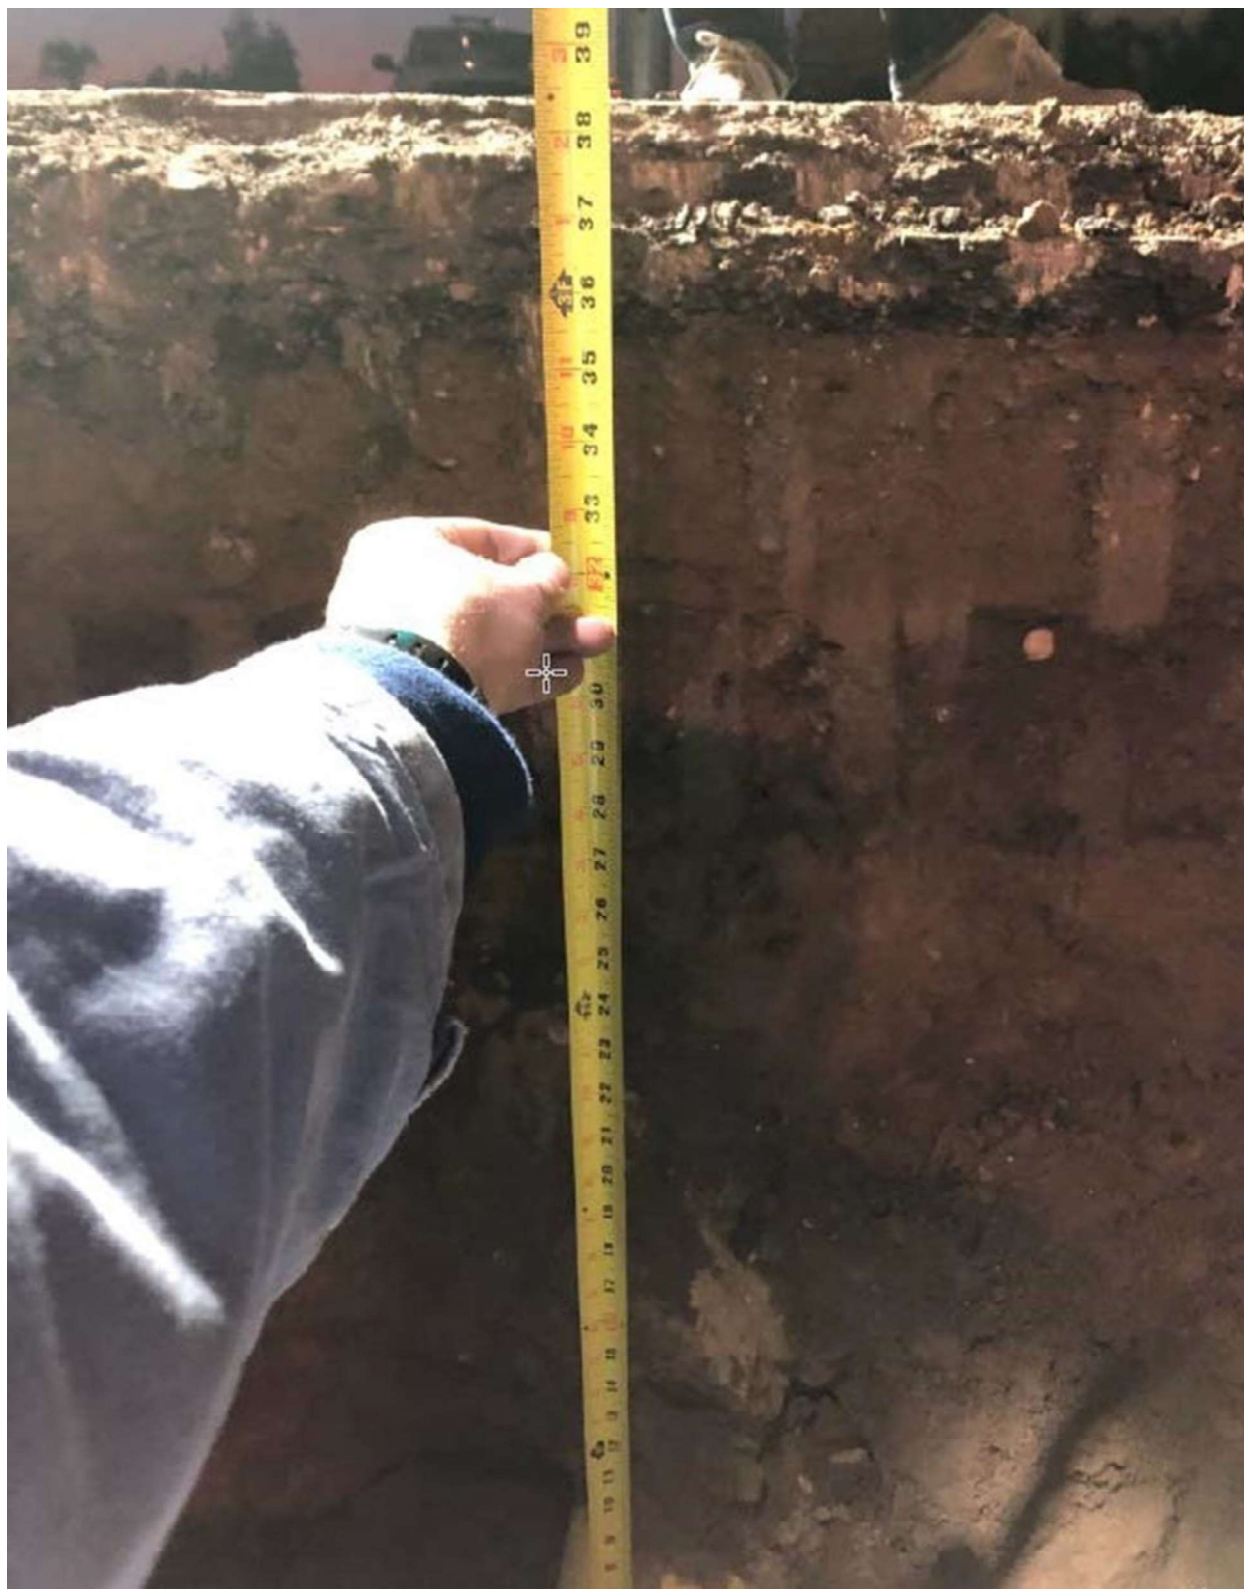
Photo 7: Damaged gas main located approximately 38.5 inches below ground surface

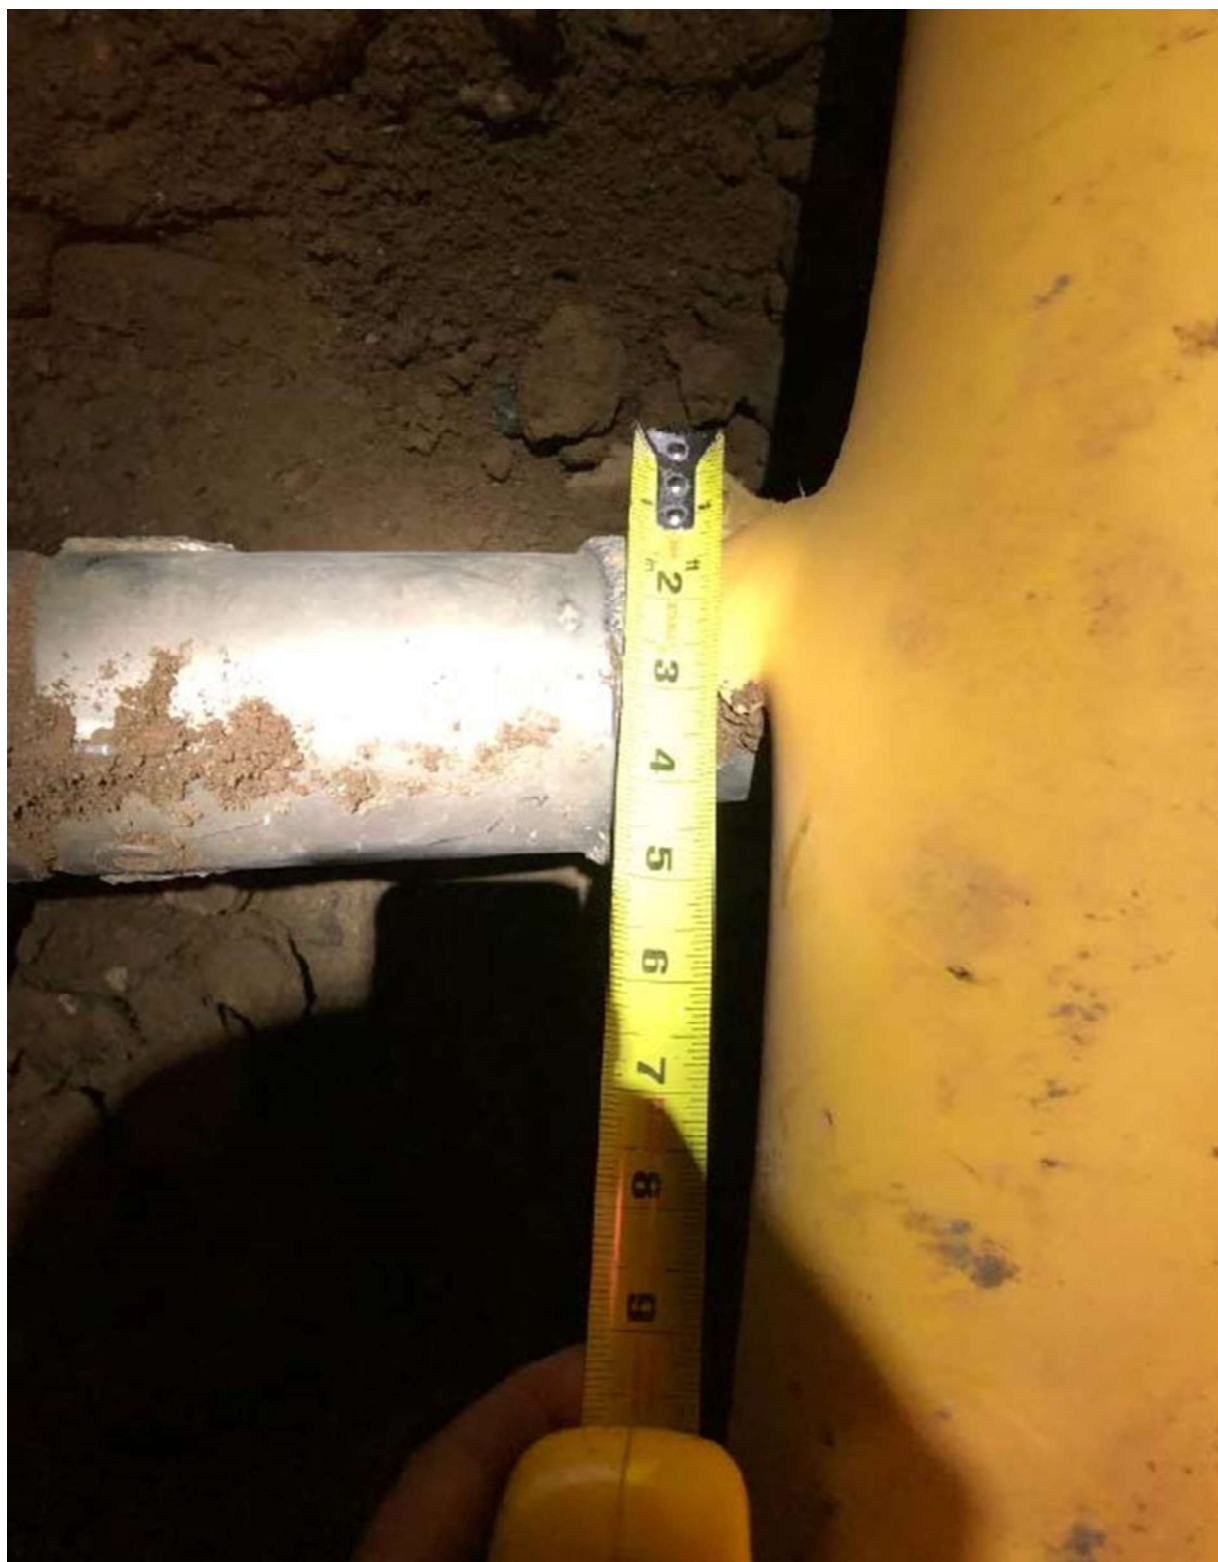
Photo 8: Drill penetrated the pipe

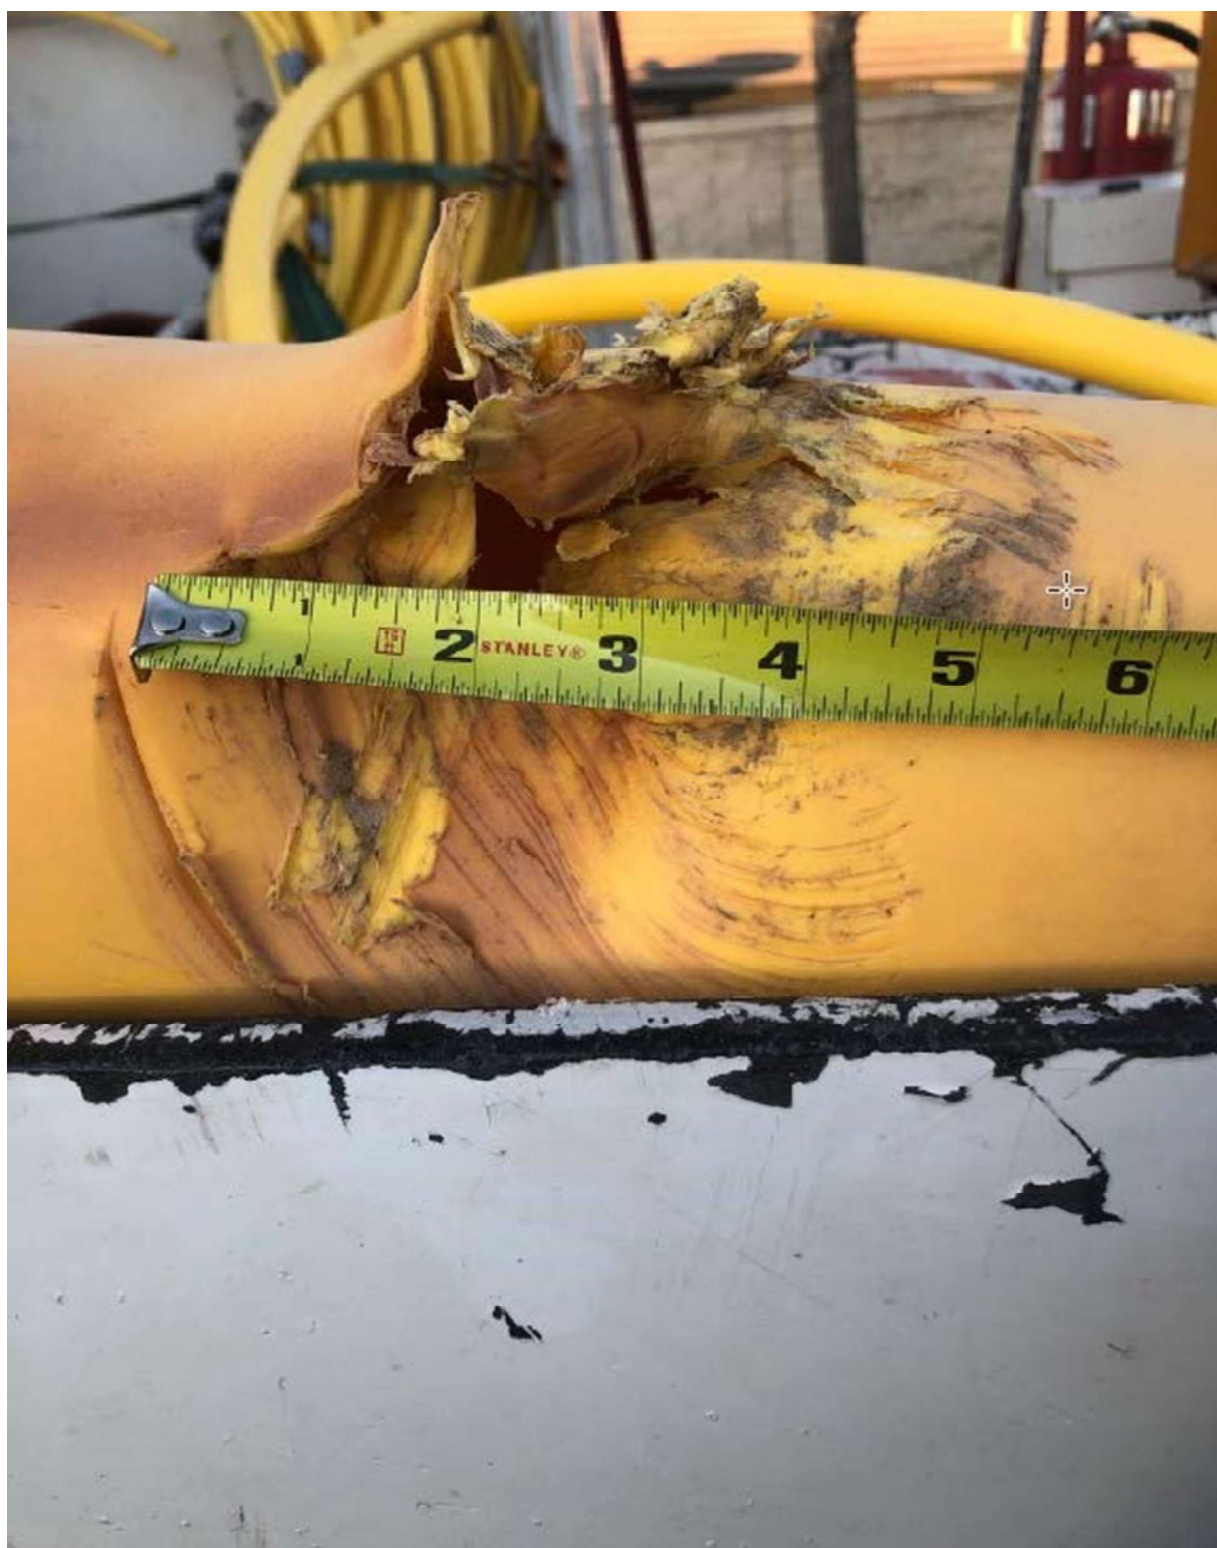
Photo 9: Damaged six-inch plastic gas main
